At one of the largest beer manufacturers in Costa Rica, the maintenance engineers were experiencing severe erosion and corrosion on a large concrete slab.

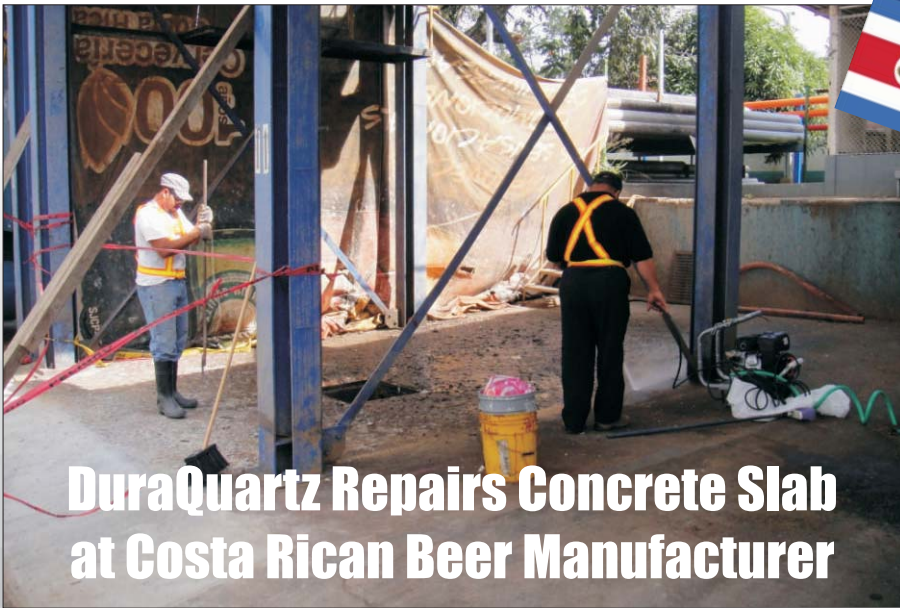
After many years of heavy truck traffic and corrosive

material spillage, this area had become pitted and severely deteriorated.
