## ENECRETE DuraFill & CHEMCLAD XC Salvage Floor at Polish Food Plant

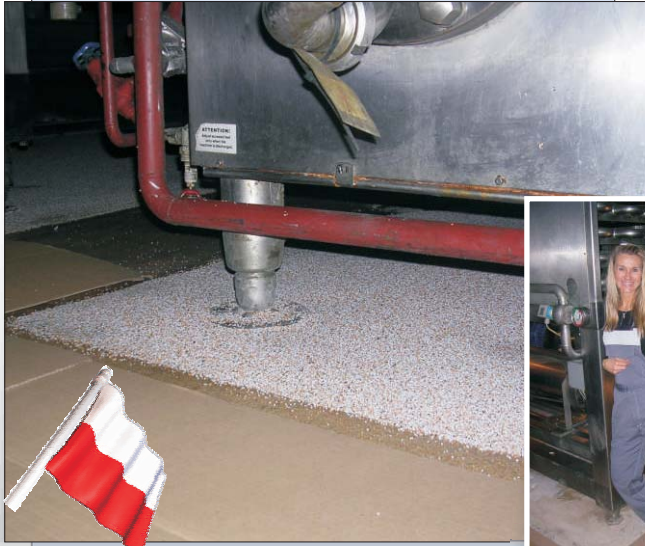
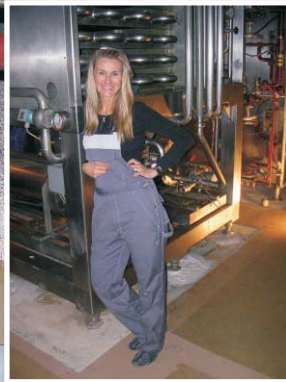
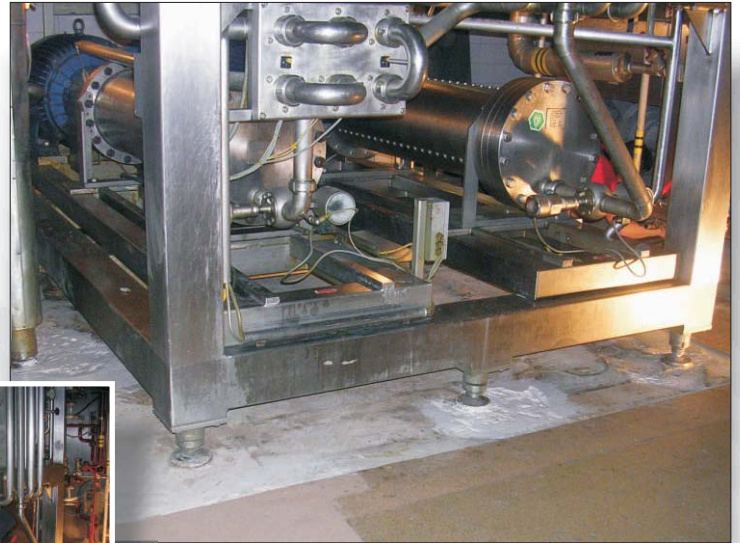
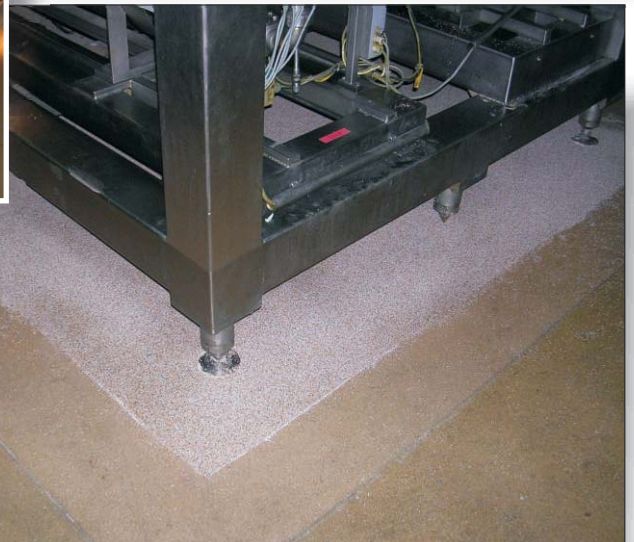
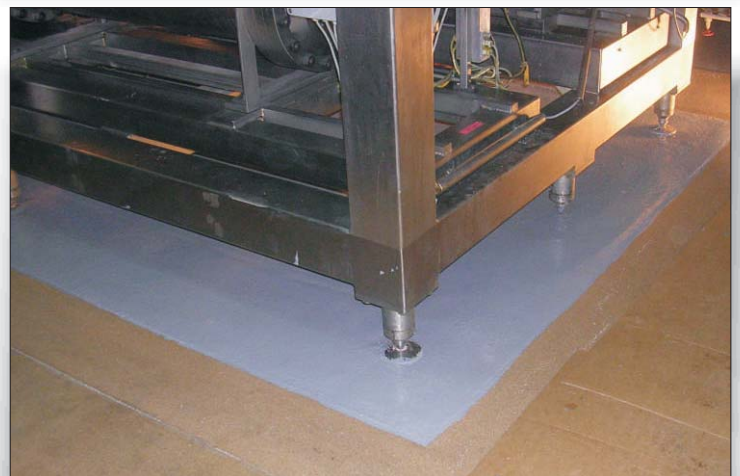
This large, international margarine producer, located in Poland, had a severe problem with some of their floor areas. These areas, which were under processing equipment that *could not be moved*, had deteriorated due to the aggressive chemicals that continuously drop on the concrete floor.

They recommended cleaning the areas and then pouring out ENECRETE DuraFill mixed with locally sourced fine aggregates. Then two coats of CHEMCLAD XC were applied to provide long-term chemical protection to these floor areas.

The entire project took just 7 days to complete with minimal disruption to plant operations.
