## 40 Units of ENECRETE<sup>®</sup> DuraFill<sup>®</sup> Used to Repair Cracked Concrete Floors in 8 Costa Rican Warehouses

**Client:** An 8 unit warehousing complex in Costa Rica.

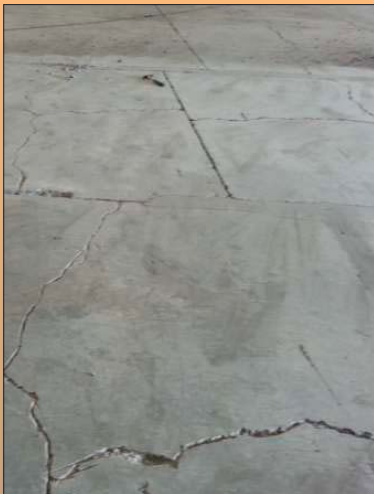
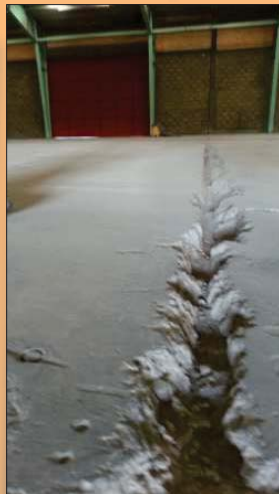
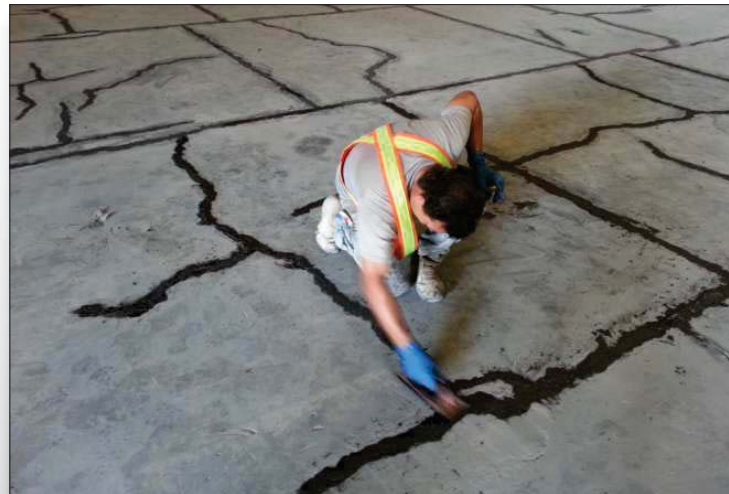
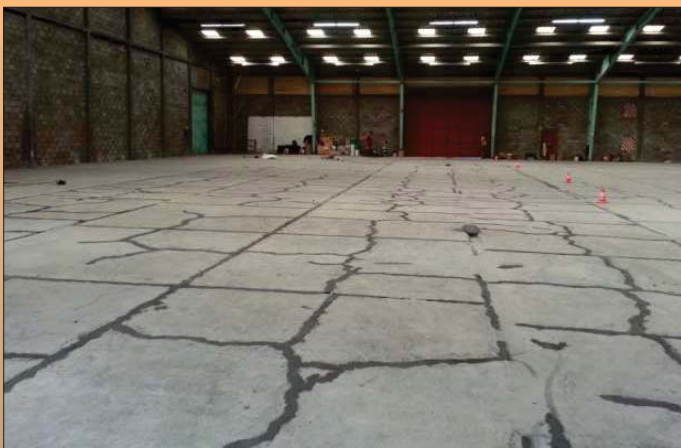
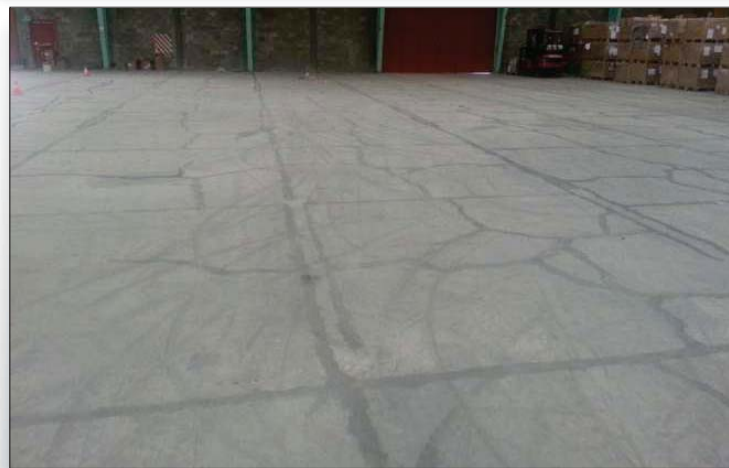
**Problem:** 20 year old warehouse concrete floors were severely cracked due to several factors, including excess weight being stored.

**Solution:** It was decided that ENECRETE<sup>®</sup> DuraFill<sup>®</sup>, mixed with locally sourced quartz sand, was the most cost effective course of action to solve this problem. All of the cracks were first opened up mechanically with a grinding wheel. The loose material was vacuumed up. The DuraFill<sup>®</sup> / sand mixture was then poured into the cracks. Before the DuraFill<sup>®</sup> was fully cured it was sanded down seamlessly to the floor's height.
