Hospital Entry Staircase Are 'Healed' With DuraQuartz, DuraFill & CHEMCLAD

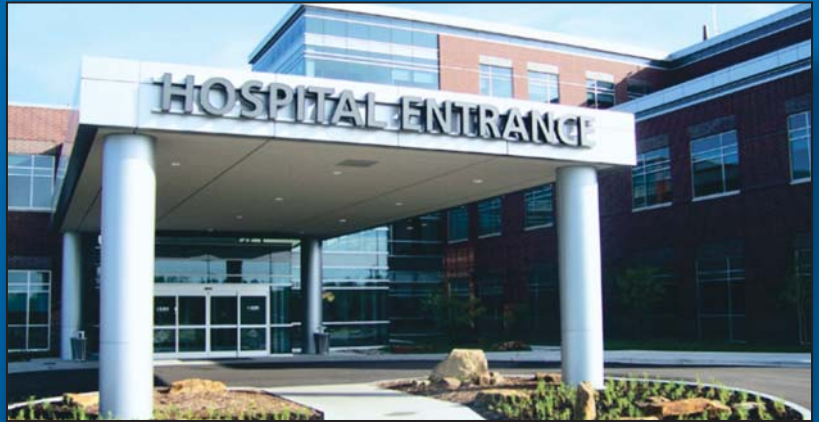
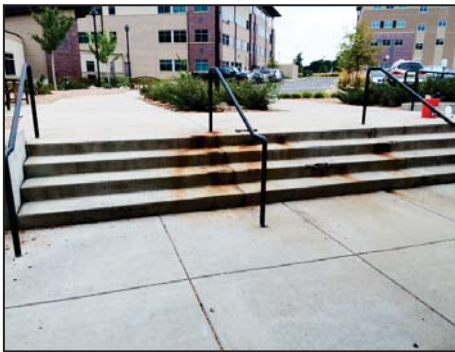
After only 12 years in use this staircase was cracked, crumbling and badly stained from the harsh elements and routine de-icing efforts during the harsh Colorado winters.

Stair noses were broken on several stairs and there were multiple areas of missing concrete.

The stairs were first cleaned with lemon juice to remove the staining. Then DuraQuartz was used to repair the stair noses and voids in the concrete. Seams and expansion joints were taped and three coats of a Durafill broadcast system were rolled out.

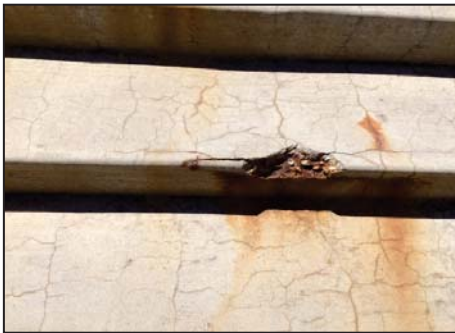
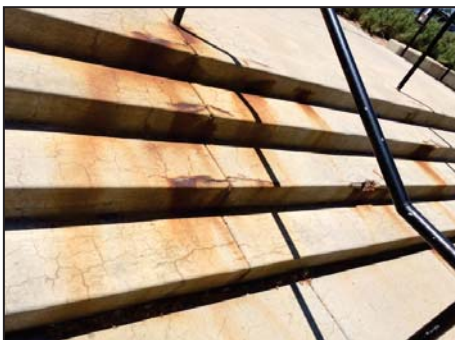
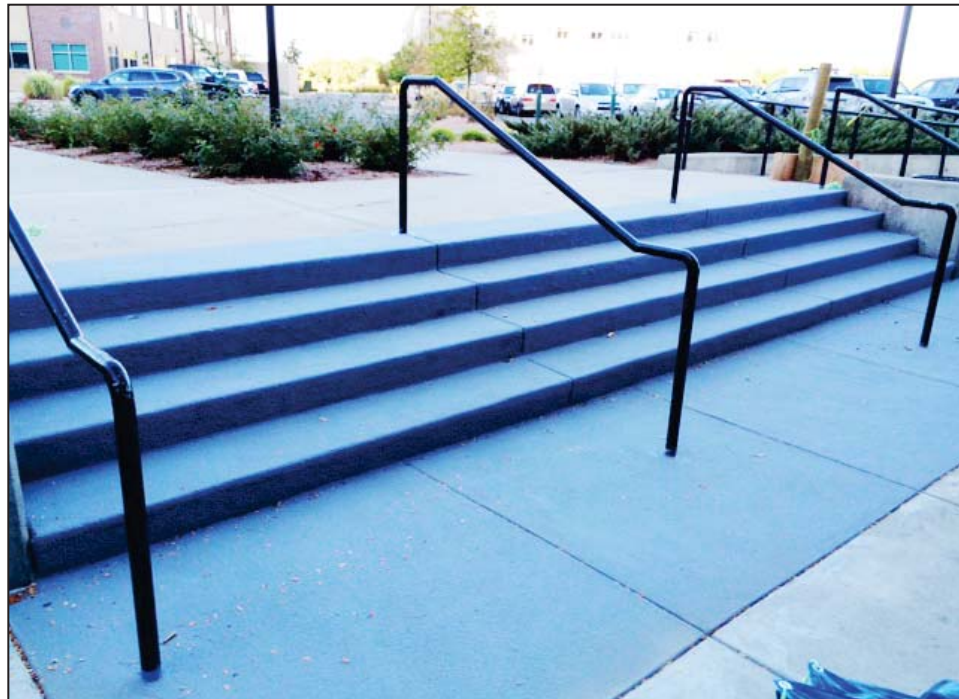
This application remedied the public safety hazard but it was an aesthetic improvement referred to as "better than 100%" by the client. This staircase is now an area of pride.
