School District Solves Safety and Unsightly Wall Issues

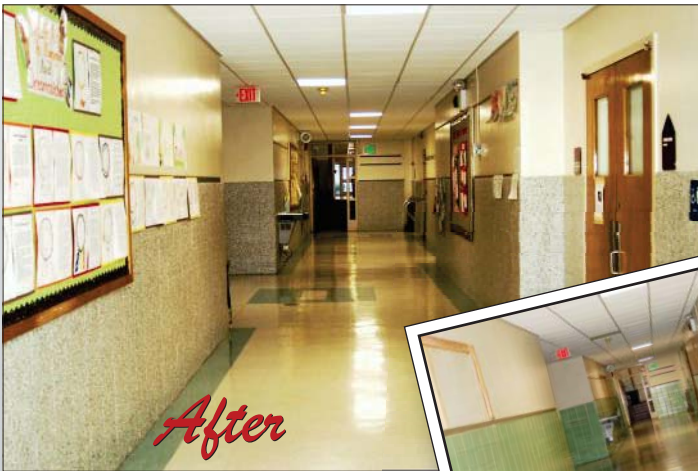
This attractive wall finish provided the school with a long-term solution to what had been a troublesome maintenance issue.

Following the appropriate surface preparation, which included abrading and cleaning the tiles, the walls were treated with a 4-coat **ENECRETE DuraFill** system. This system included rolling/brushing

a layer of **DuraFill** and then manually broadcasting colored decorative vinyl chips/flakes into the wet **DuraFill** and letting this first layer set overnight. After it has dried a trowel is used to smooth out and remove any loose chips/flakes.

Additional similar layers – a total of 3 – were applied each day followed by a final layer of just the **DuraFill** clear resins – about one week total.

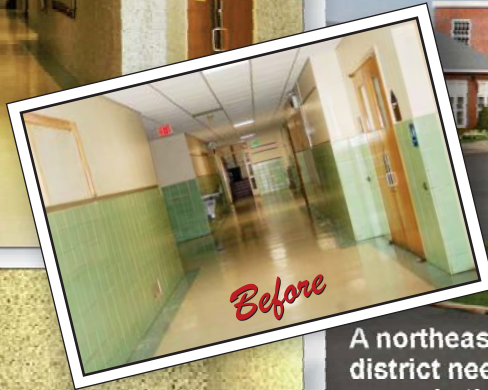
Before

A northeastern school district needed to upgrade their facilities' hallways and restrooms. The original wall surfaces were ceramic tiles that had become cracked with missing tiles in many locations. This condition was a serious safety concern for the district officials.

This **DuraFill** broadcast system application also included filling in any damaged and missing tiles with **ENECRETE DuraQuartz**.
