## ENECON's DuraQuartz RR Puts Hospital Parking Garage Back In Service In Just 45 Minutes

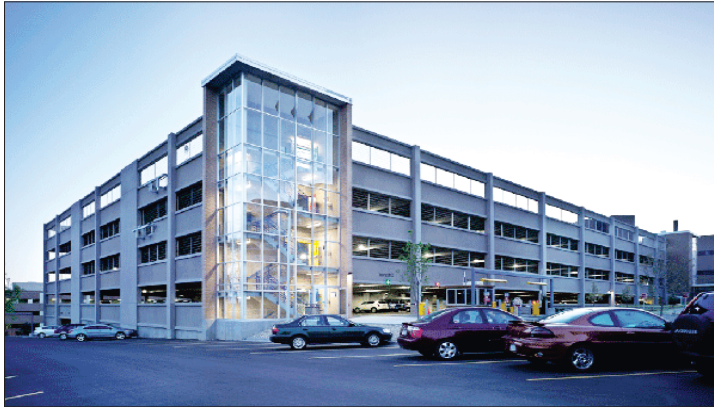
In Cyprus, the entrance to a hospital's multistory parking garage had severe concrete damage along its in-ground drainage channel from years of heavy vehicle traffic in and out of the garage.

Because of the damaged concrete, the channels were leaking to the parking level below. This needed to be fixed with minimal disruption to the hospital's busy parking garage entrance.

The damaged concrete surrounding the drainage channel, approximately 80 linear feet, was first removed.

The area was primed with the DuraQuartz RR resins only. The supplied sand was then added and the DuraQuartz RR was then troweled evenly to match the exiting concrete.

Much to the delight of the maintenance team, this garage entrance was put back into service just 45 minutes later.
