## Damaged Cooling Tower Support Base At Northern California Hospital Repaired & Protected With DuraQuartz & ENESEAL

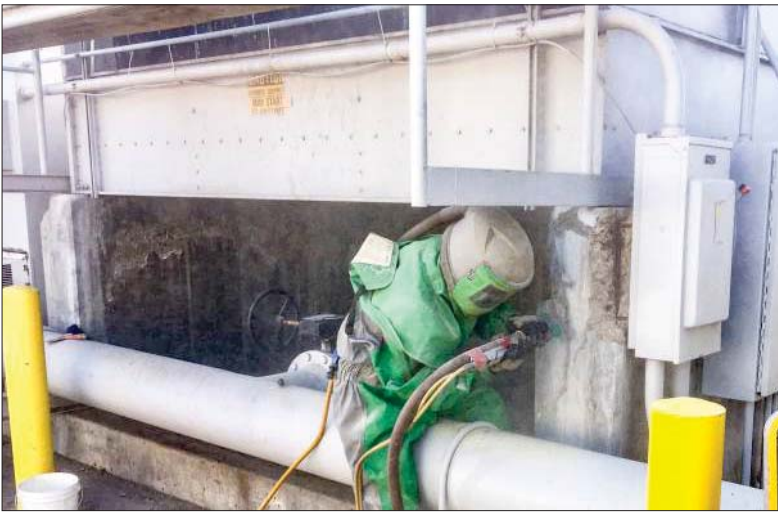
A northern California hospital's rooftop cooling tower concrete support base was badly damaged. This was from years of service in atmospheric corrosion and occasional seismic activity. The hospital needed a fast and cost effective solution to repair the damaged concrete.

1. All loose concrete pieces were removed. The concrete was ground or grit blasted to provide an adequate surface profile. The exposed rebar was coated with ENESEAL CR before the concrete was primed.
2. DuraQuartz LW was applied to the vertical and overhead surfaces and a former was made to restore the original shape of the base. DuraQuartz was also used in all other non-vertical or overhead areas.
3. All the DuraQuartz was polished smooth and then coated with two coats of ENESEAL CR to encapsulate and protect the base from future exposure to the elements.
