Clarifier Tank Rim Repaired With DuraFill

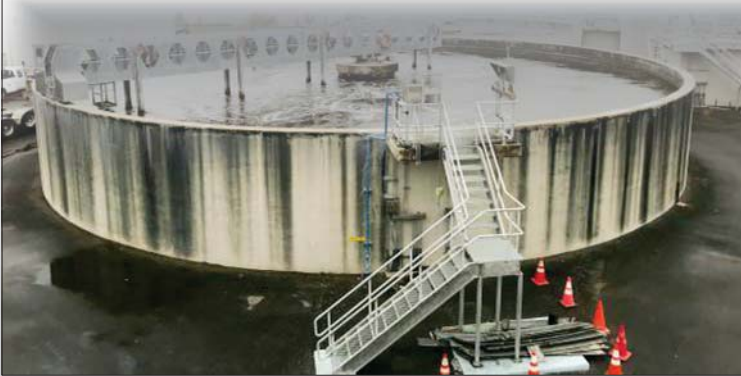
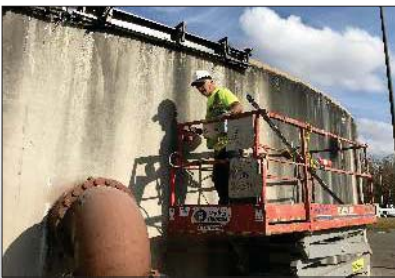
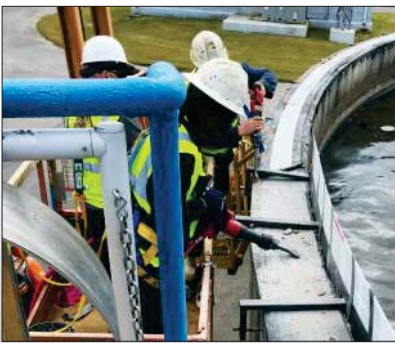
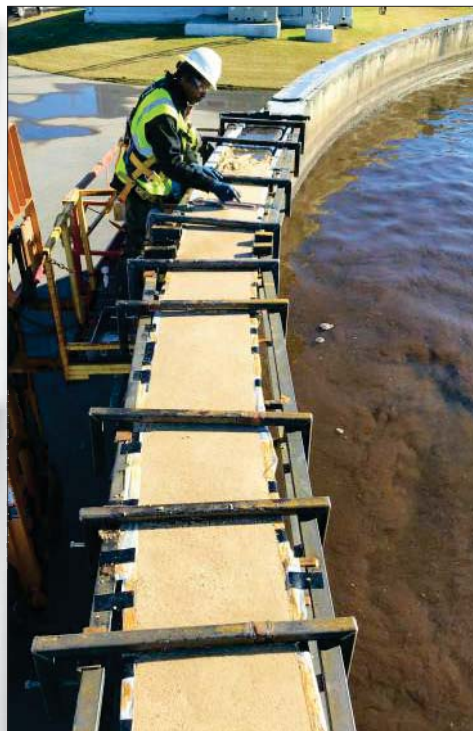
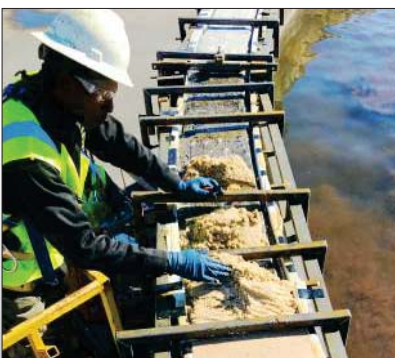
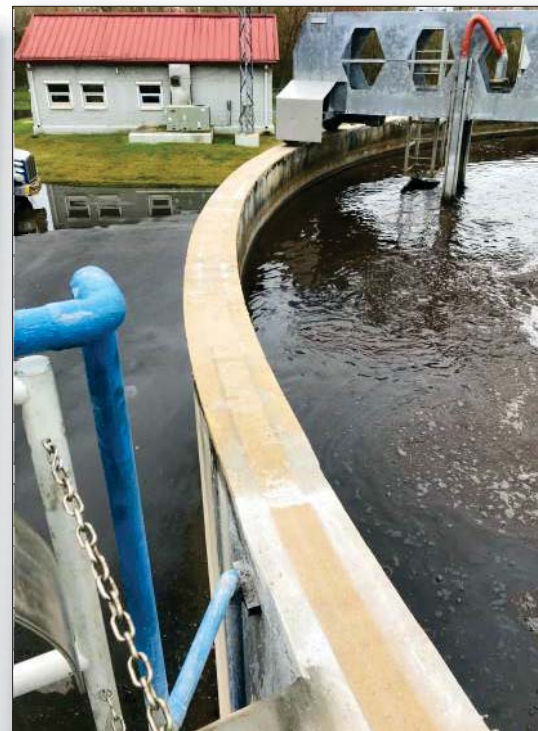
The steel plating on this clarifier tank rim, which serves as a track for the tank's scraping bridge wheels, had been in service for 15 years. Located at a Southern Louisiana wastewater treatment facility, the bridge makes approximately one full rotation every minute.

The plating weld seams began breaking causing the concrete underneath it to also break. The bridge wheels were being damaged as a result of the broken concrete.

cost effective solution. The plating was detached and any loose or crumbling concrete was removed using an air chisel hammer. A former was constructed and clamped to the tank rim to prevent concrete from falling into the tank.

DuraFill was mixed with a locally sourced silica quartz sand and applied to the tank's rim. The former also allowed the applicators to keep the DuraFill level during application. The entire project only used 5 units of DuraFill, but it saved the maintenance team at the plant tens-of-thousands of dollars.
