ENECON® NEWS

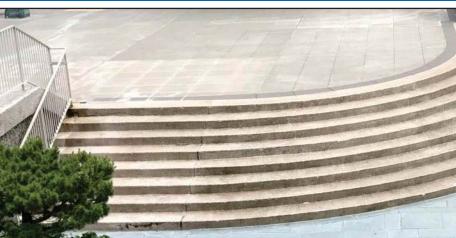
These outdoor courtyard steps in Seattle, WA have heavy foot traffic all day long from general sidewalk use and office building/restaurant loose material. entry ways in the courtyard. Over the past decade. the condition of these steps has deteriorated with cracks and concrete loss.

The steps were first pressure washed to remove years of dirt and debris. Next the cracks were "Vground" to remove

DuraQuartz was then applied to fill and smooth all the cracks. Several other areas required larger **DuraQuartz** repairs to fill large holes, a lengthy crack on a riser and replace and secure several pieces much like a jigsaw puzzle.

Finally, two coats of DuraFill and a blended colored quartz aggregate were applied in the typical broadcast fashion.
