Hospital Saves Almost \$500,000 By Repairing Damaged Concrete With DuraFill Instead Of Replacing It

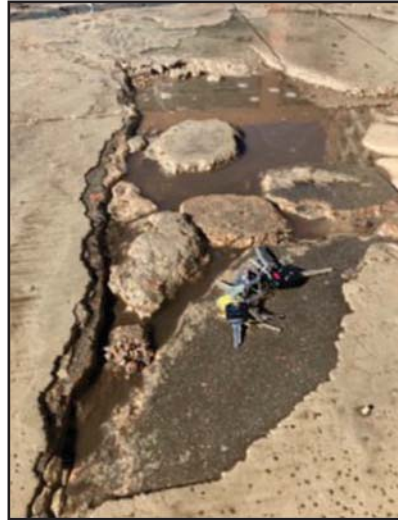
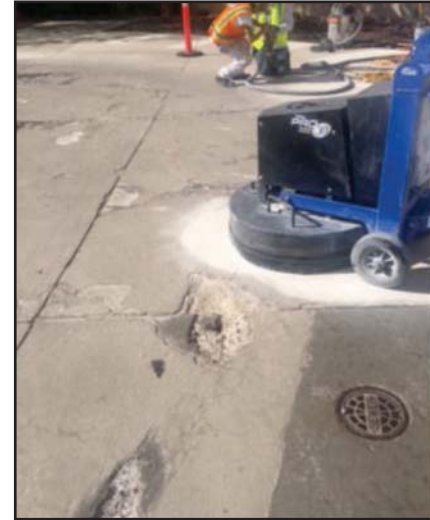
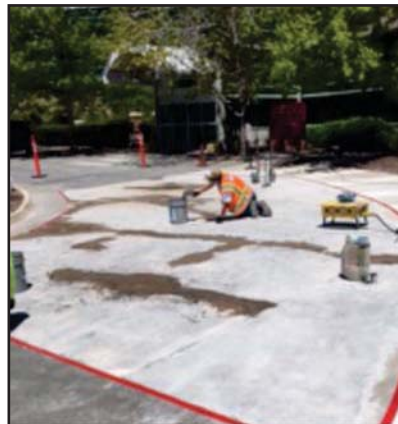
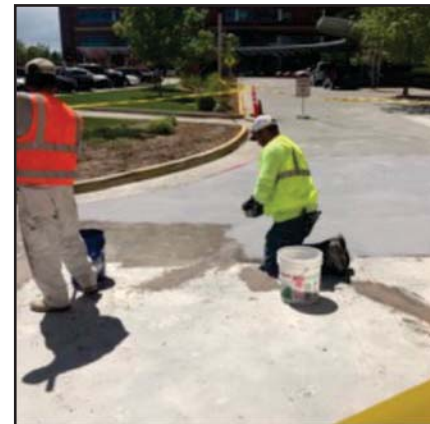
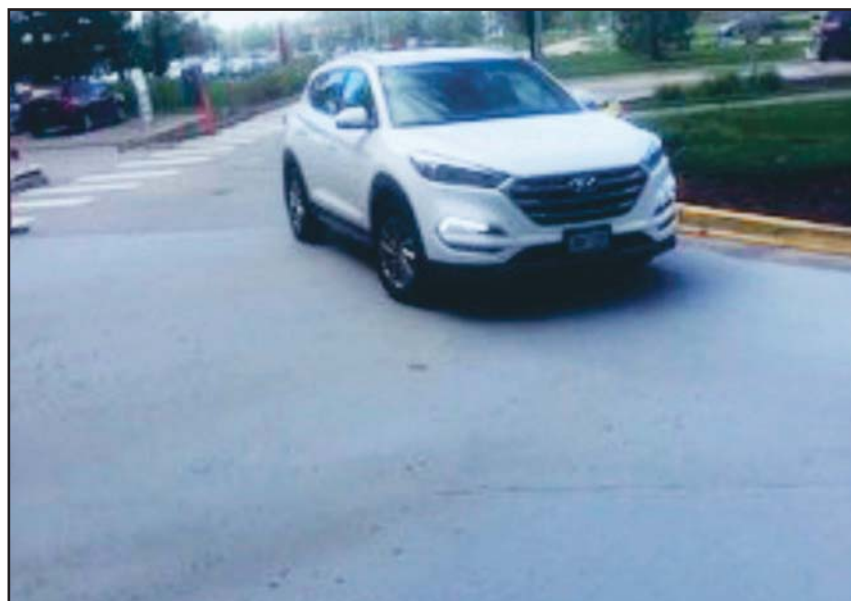
The main driveway at this Colorado hospital had slowly begun to erode over the years. Severe weather, freeze/thaw and ice melt had caused dozens of potholes. Some of the potholes were as large as four feet in diameter and up to six inches deep.

Repeated attempts to patch the pot holes and resurface the entire driveway with a thin layer of a “super industrial, cementitious substance” had all failed.

The first step was to remove the failed thin layer by using a large grinder. All loose material inside the potholes was removed and the holes were filled with *DuraFill* mixed with common play sand.

Finally, two broadcast applications of *DuraFill* and colored aggregate were applied to achieve the desired color.

This project was completed in just three days over a long holiday weekend. The maintenance team was thrilled with the results and the incredible savings.
