ENECLAD FPS 2000 Revitalizes Main Entrance For This Pennsylvania Manufacturer

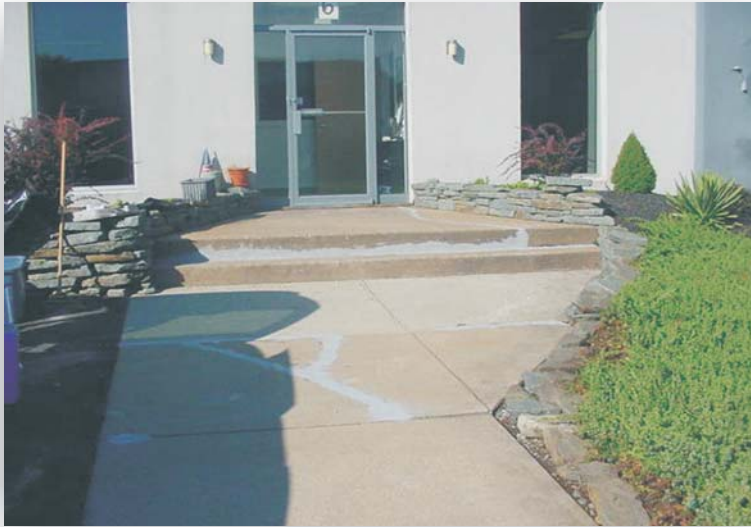
The main entrance for this manufacturing company was showing its age. The concrete was cracked and deteriorated. The conventional approach would have required removing the old concrete and pouring new steps and walkway. The corresponding downtime would have presented problems since this entrance was the main access to the facility.

The concrete was first power washed and allowed to dry. DuraQuartz was used to repair all the cracks and heavily damaged areas. ENECRETE Self Priming Screed (SPS) was then applied to smooth out the rough

concrete surface. Finally, two coats of ENECLAD FPS 2000 were installed by roller and a #46 aluminum oxide aggregate was 'back-rolled' into the topcoat to provide for a safety, non-slip surface. This project was accomplished in just two days to the complete satisfaction of the building owners.
