## Ceramics Factory Roof in the Philippines Repaired & Protected With ENESEAL HR

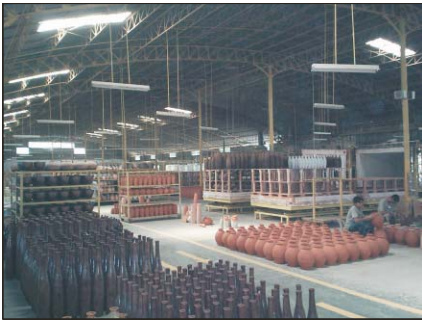
*This ceramics factory, located near Manila, had a badly corroded metal roof with hundreds of holes in it. Water would drip all over the factory during the rainy months. The factory workers would routinely squeeze into the sections of the factory where there was no water dripping!*

*After cleaning the roof, self-adhesive fiberglass mesh was applied over all the holes in the corrugated metal sheets. This was followed by a two-coat application of ENESEAL HR.*

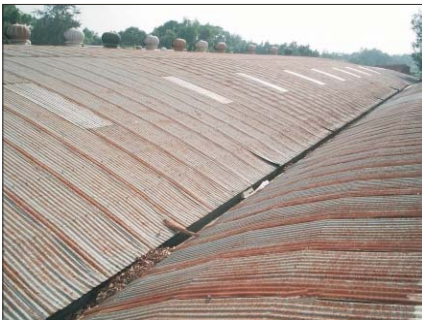
Note the holes in roof.
