ENESEAL HR Solves Leaking Hangar Problems at Indian Airport

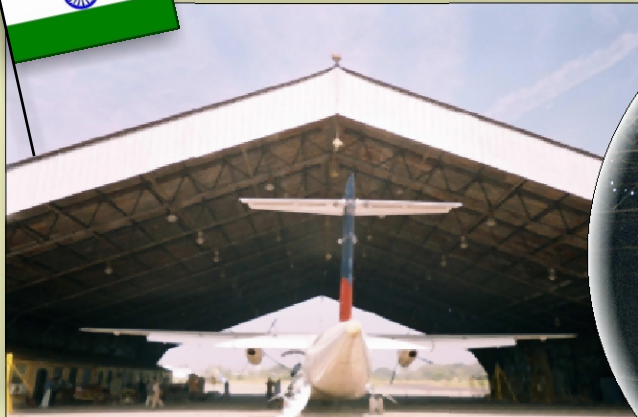
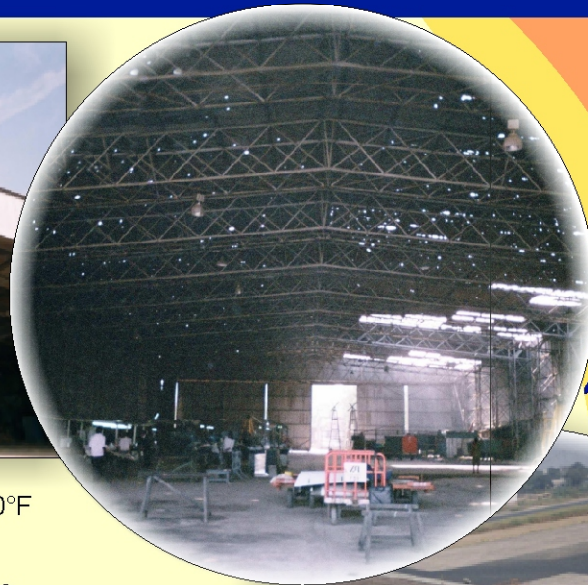
Before

Engineers at the airport in Calcutta were tired of “seeing stars” through the roof of some of their airplane hangars. Conventional tar-felting could not provide the long-term repair solution they were looking for on these corrugated metal roofs. Each hangar is over 32,000 square feet.

All roof surfaces were cleaned and a rust “converter” was used to treat rusted areas. Fiberglass reinforcing mesh was used to bridge holes in the roof with ENESEAL. Two additional coats of ENESEAL HR were then applied to completely seal the entire roof area. The project was completed in about 80 days – well ahead of the stipulated 90 day schedule.

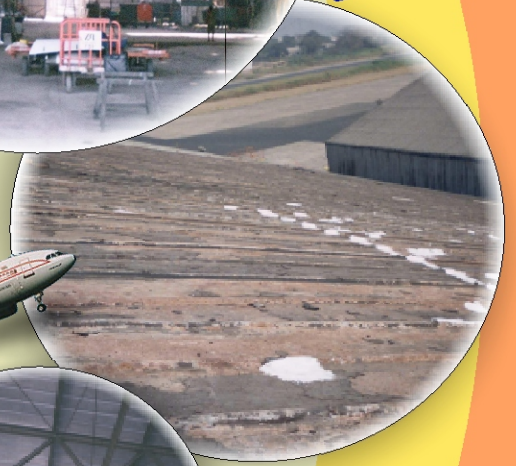
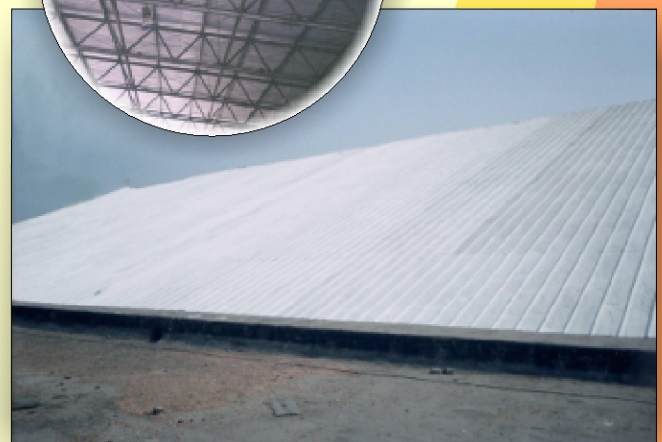
After

Just two days after the application was finished, torrential rains buffeted the city. To the amazement of the airport engineers, the ENESEAL coated roofs were completely water-tight. They are now in the process of tackling other problem roof areas at the airport.
