ENESEAL CR Protects Venting Pipes on German Container Ships

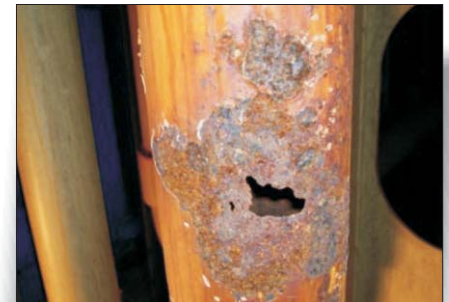
Oil tank ventilation pipes located on German container vessels, part of a major German shipping line, were suffering from heavy corrosion causing pitting and massive holes in the pipes. Damage of this nature to these pipes would cause oil leaks as well as vapor leaks which could be a health risk to those on board.

Holes caused by corrosion

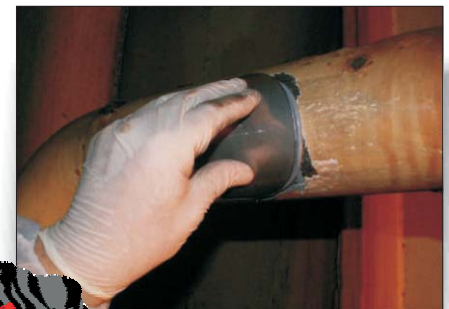
Patch applied to hole

After minimal preparation of the pipes, the large holes were repaired with stainless steel patches shaped to the contour of the pipes and adhered using DurAlloy. A first coat of ENESEAL CR was then applied. The pipes were wrapped with a fiberglass reinforcement tape and then overcoated with a second layer of ENESEAL CR creating a highly durable, corrosion resistant, elastomeric 'skin' providing extraordinary environmental protection.

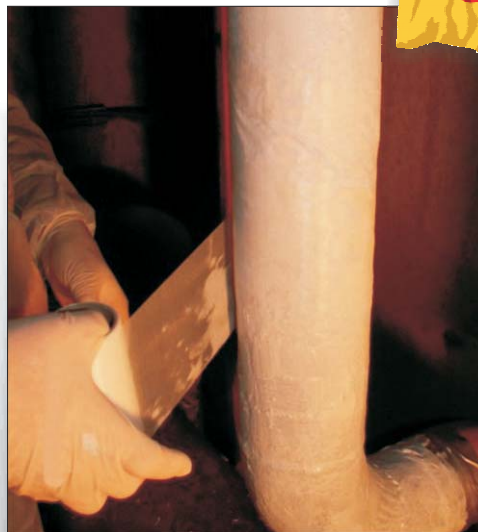
Fiberglass reinforcement tape over 1st
