## ENESEAL CR & HR Rescue Port Authority Roof in the Philippines

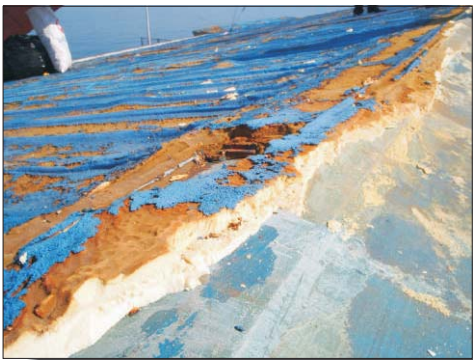
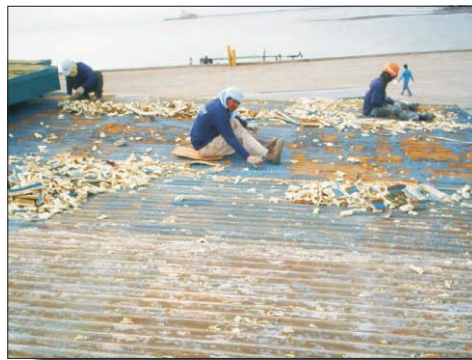
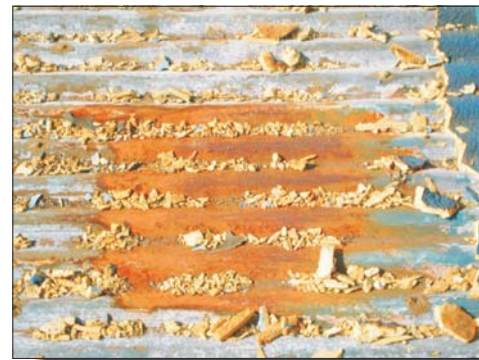
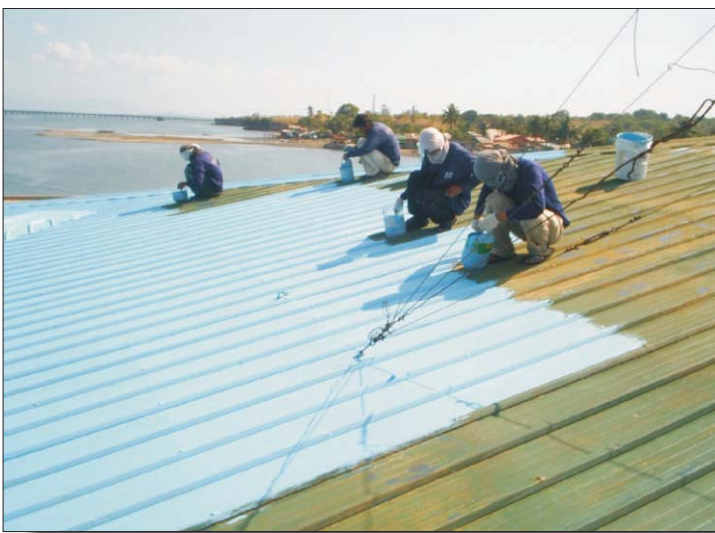
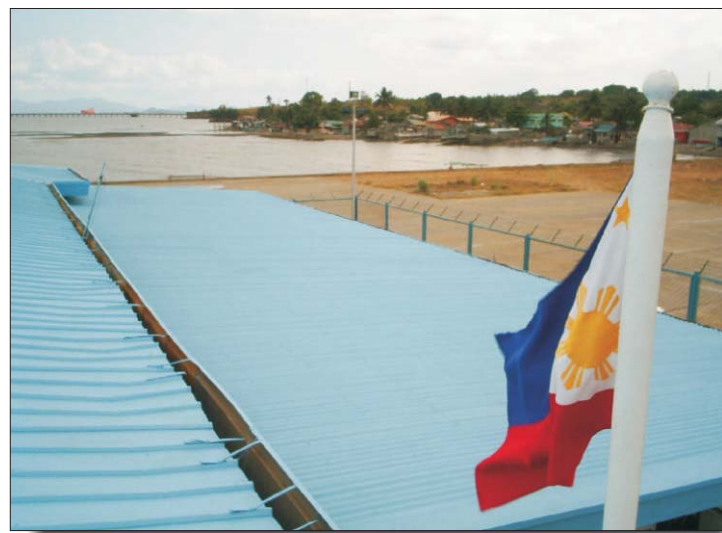
This metal roof of an administration building in a local Port Authority in the Philippines had deteriorated severely due to the harsh marine environment. The foam insulation material that had been applied only 4 years ago was in very poor shape.

After stripping off the foam insulation, the entire roof was then pressure washed and inspected for holes in the metal structure. These were repaired with DurAlloy and reinforcement tape or

metal patches secured with DurAlloy. Any open seams were caulked and sealed.

**ENESEAL CR** (tinted blue) was then applied over the entire roof area to provide long-term corrosion protection followed by **ENESEAL HR** (also tinted blue) to provide a heat refractive surface. **Problem solved - quickly and cost effectively!**
