## Town Park Uses DuraQuartz & ENESEAL to Repair & Protect Concrete Ceiling

**Client:** Parks and Recreation Department in New York State.

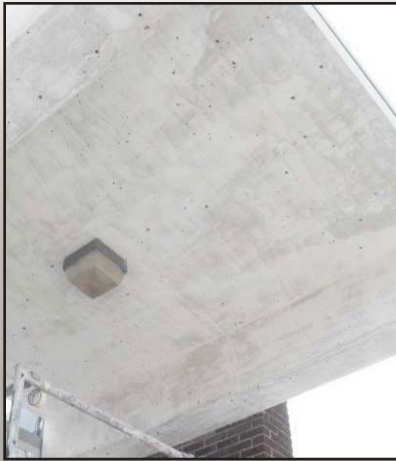
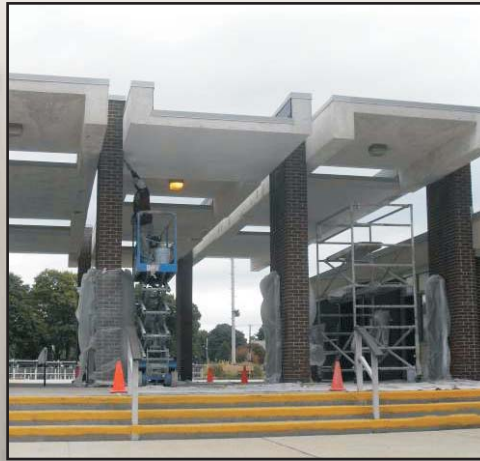
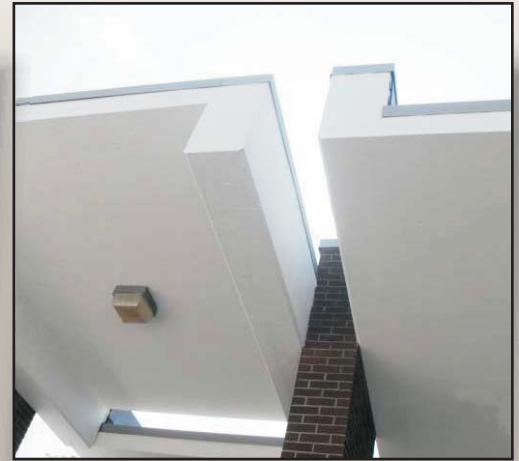
**Problem:** The park's entrance ceiling was showing signs of water damage, spalled concrete, exposed rebar and missing failed coating. The Town was concerned that loose concrete could create a safety issue for park users.

**Solution:** A combination of power washing and hand grinding was used to thoroughly clean the surface and remove any loose concrete. Any exposed rebar was coated with **ENESEAL CR** and all damaged concrete areas were repaired with **ENECRETE DuraQuartz** with *light weight aggregate*. **ENESEAL HR** was used as a final topcoat.
