Flour Producer in Honduras Protects Wheat Grain Silos with ENESEAL

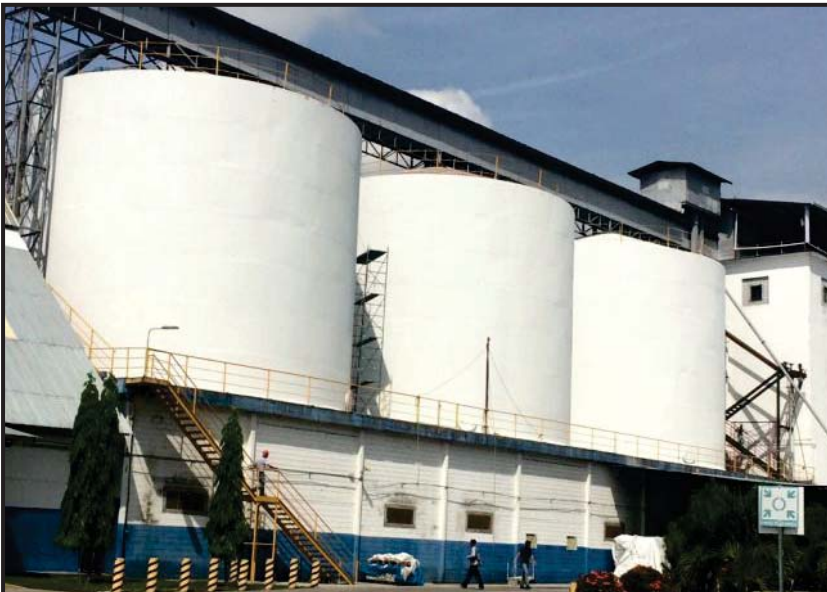
This flour mill in Honduras had been struggling with corrosion and leaks on their main storage wheat grain tank silos.

The mill's maintenance engineers had unsuccessfully tried to solve these problems using conventional repair products and ordinary paint but these only lasted for 1 year before they began exhibiting accelerated corrosion.

The tanks were pressure washed and then manually prepared to remove any loose rust and failed paint.

ENESEAL CR was applied as a corrosion inhibiting primer. All holes were repaired with fiberglass mesh and ENESEAL HR. A final coat of ENESEAL HR was then applied to complete the application to the plant's total satisfaction.
