Corroded Steel Cooling Tower Support Beams Are Protected With ENESEAL CR

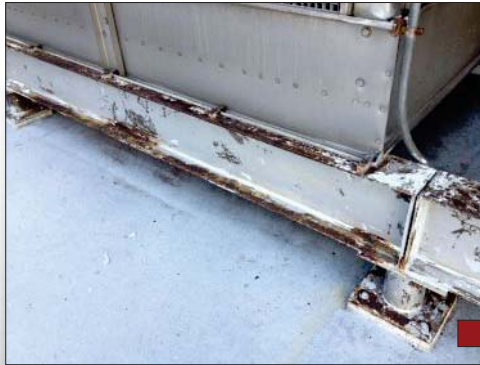
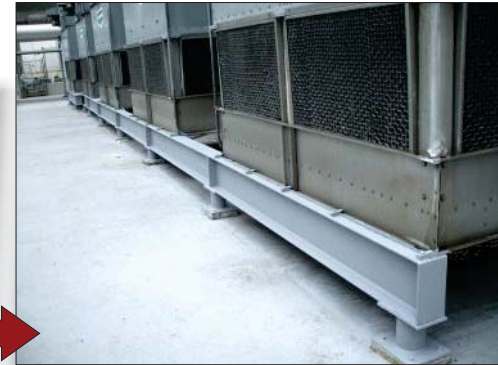
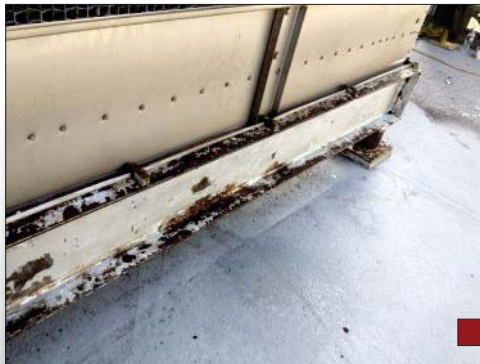
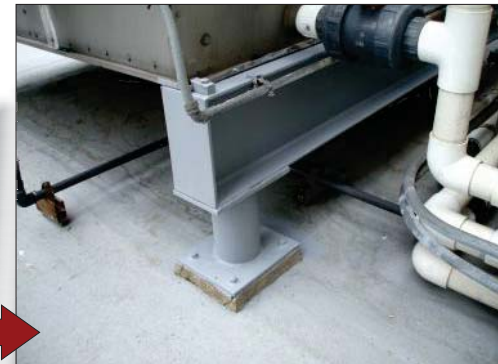
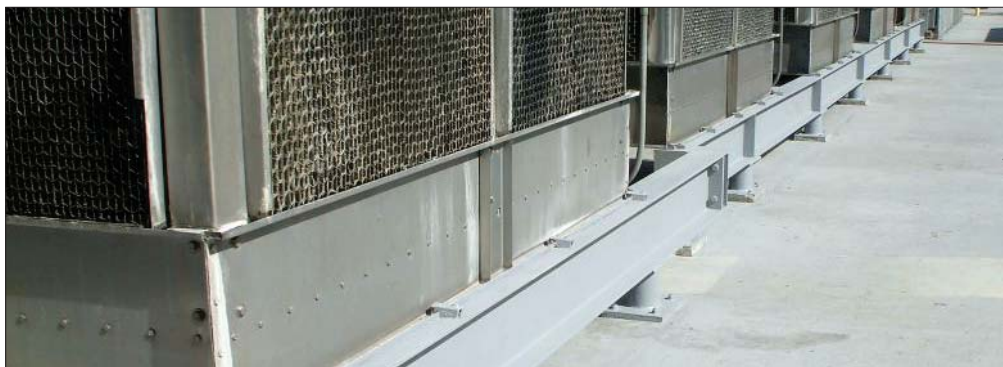
A downtown Seattle office building has these large cooling towers on top of galvanized support beams. The beams were corroding due to the environmental conditions in which cooling towers historically operate.

The support beams pictured had been painted with a "high-quality" marine paint just one year prior to this project taking place. The previously applied paint was already peeling off due to the prior coatings' inability to bond to the galvanized surface of the support beams.

The beams were first prepared by pressure washing and then hand grinding was used to remove any remaining paint and rust. Once the surface was properly prepared, two coats of ENESEAL CR, tinted to a custom gray color, were applied to provide long term corrosion resistance.
