Client: Pennsylvania Power Plant

ENESEAL Solves Corrosion Problems on Critical Electrical Switchgear Cabinets in Western PA

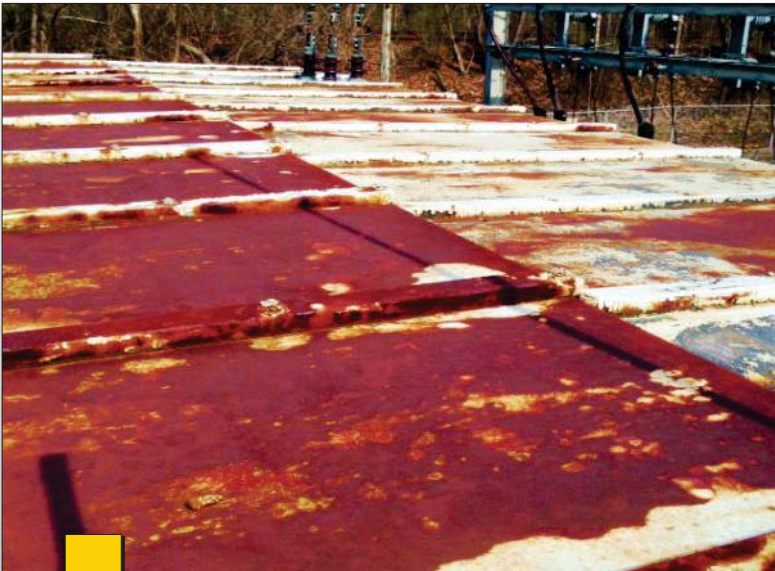
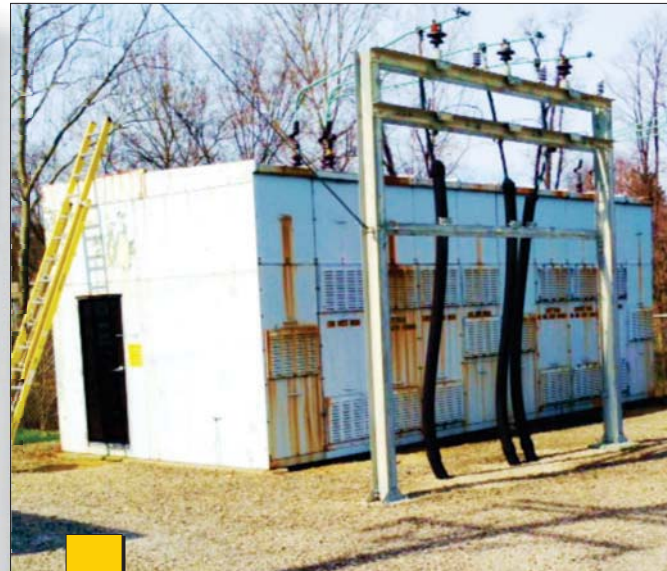
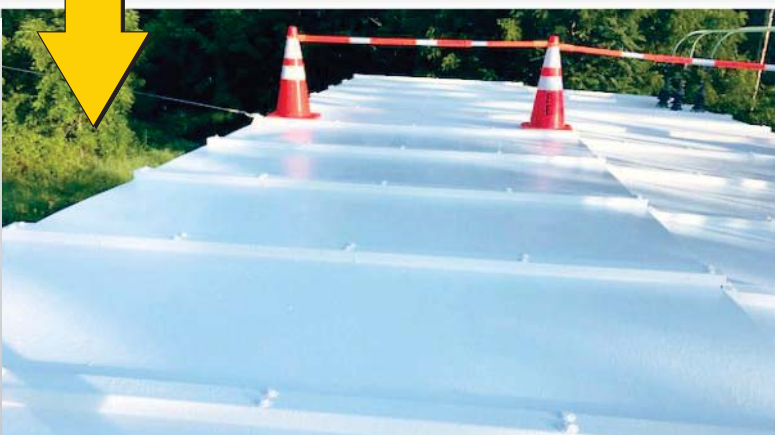
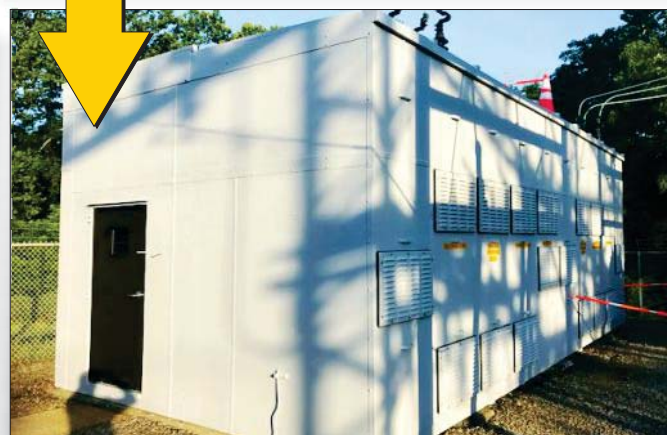
Problem: This badly corroded 30'L x 10'W x 12'H switchgear cabinet was vulnerable to leaks due to severe corrosion. Any water that leaked into the cabinet would possibly destroy critical electrical equipment inside.

Solution: The surface of the roof was ground and cleaned. A rust converter was then applied and the roof's end caps were replaced. Two coats of ENESEAL CR were applied for corrosion protection. One coat of ENESEAL HR, to provide heat refraction properties, was applied to keep the equipment inside cool.

The exterior walls were also ground then wiped down with denatured alcohol, followed by three coats of ENESEAL CR.
