University Building Leaks Stopped With ENESEAL

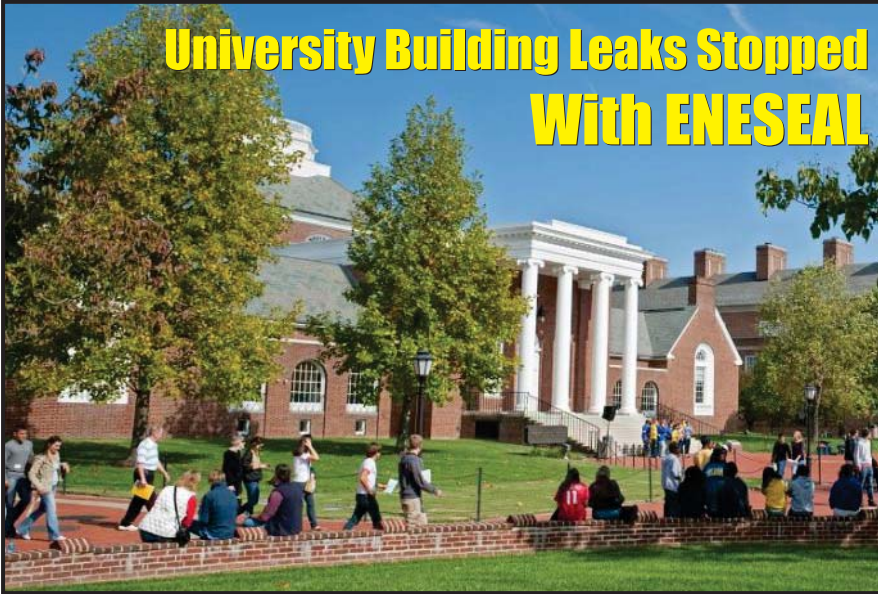
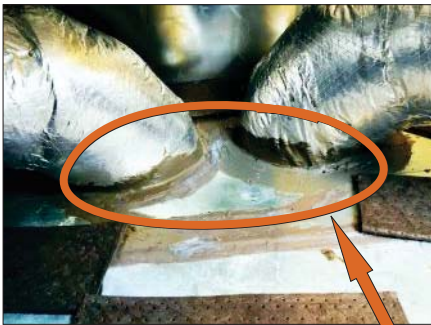
Before...

An area where these roof top air circulation pipes converge to enter a university building was vulnerable to leaks from rainwater. When this area leaked, water would drip down to laboratories below filled with expensive equipment.

The pipes are spiral wound stainless steel, so corrosion is not a problem, however rainwater was entering the pipes through the pipe-winding joints.

Earlier spot repairs circled in the before photos were not effective. The university maintenance team needed a better solution.

It was decided that all the joints would be sealed with specialized joint sealing tape followed by spray applied two coats of ENESEAL CR.

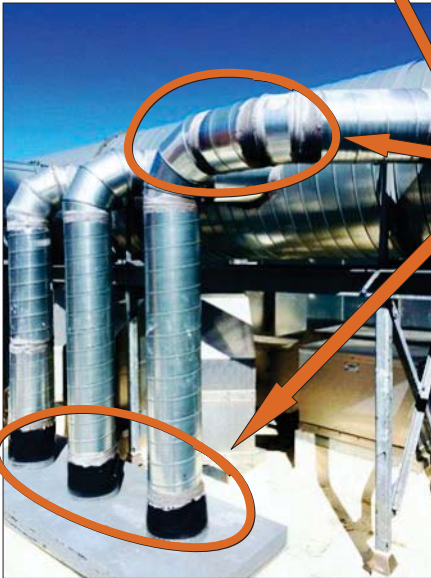
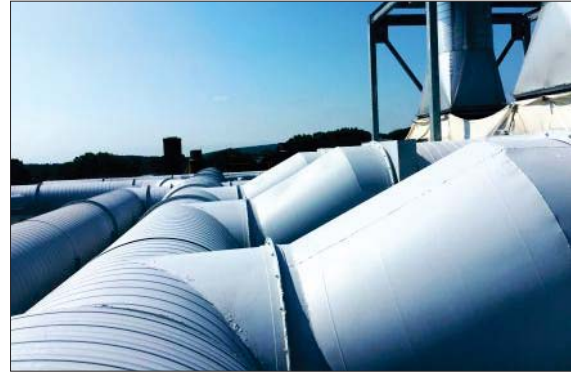
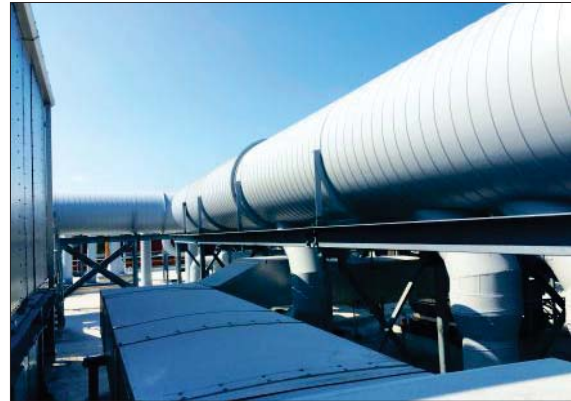
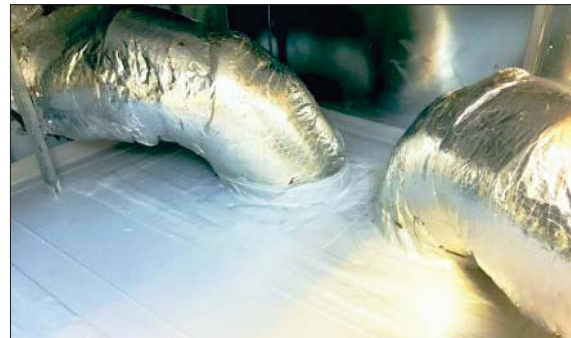
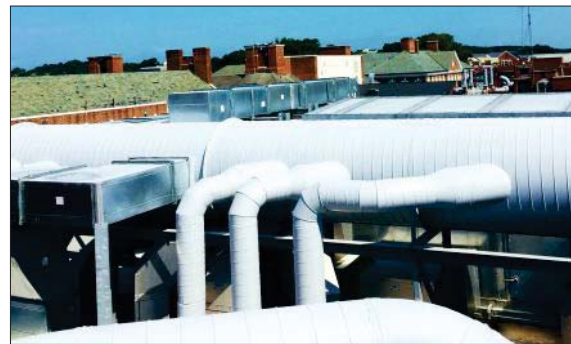
After...

The ENECON solution solved the leak problem and the university maintenance team is extremely happy. The local ENECON Engineering Specialist is now looking at other similar solutions on campus.
