Aviation Fuel Storage Tank In Romania Protected With ENESEAL & CHEMCLAD

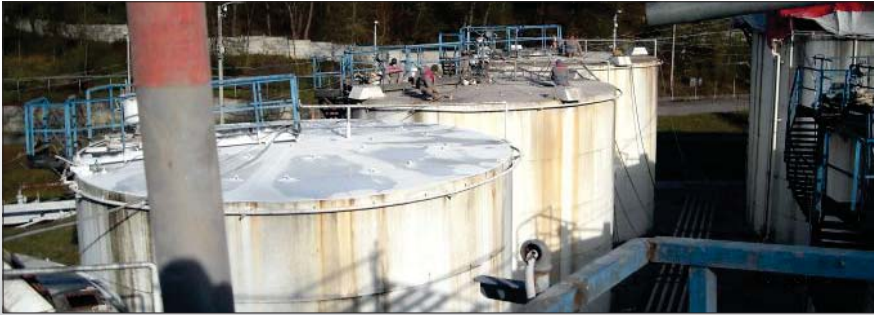
This large aviation fuel storage tank located in Romania was badly corroded. The aluminum top of the tank corroded over time due to many years of environmental exposure. The inside of the tank, exposed to the corrosive aviation fuel, had been previously protected with a coating. The original coating failed, causing the tank interior to be corroded as well.

The tank top was first mechanically prepared and sanded by hand. The weld seams were then stripe-coated with ENESEAL HR. This was followed by two sprayed coats of ENESEAL HR over the entire top area.

After making some small repairs to the inside of the tank, the area was grit blasted to the required SA 3 roughness. CHEMCLAD SC was then applied to a thickness of 200 microns (8 mils).
