Repair vs. Replacement

The Cost Effective Solution

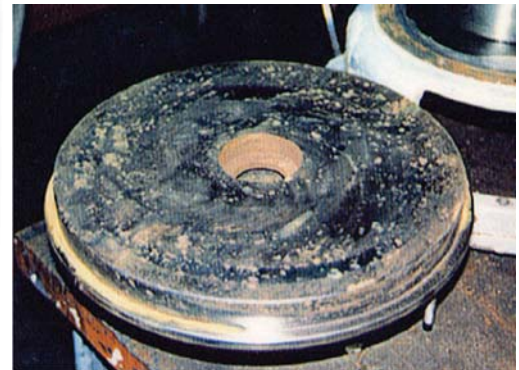
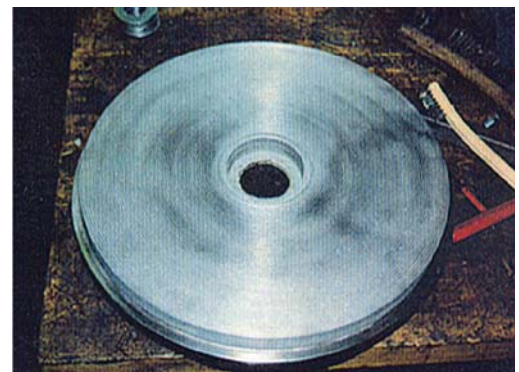
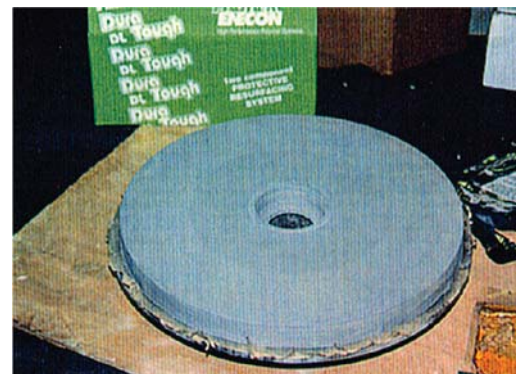
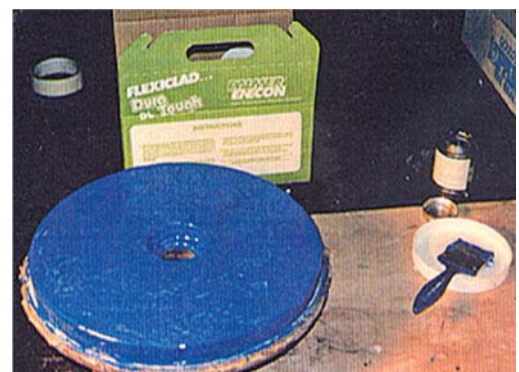
The maintenance supervisor and his crew had a damaged pump from their service water system disassembled and on the workbench. The back plate of the pump had severe cavitation damage; and, to make matters worse, the pump shaft was also badly scored in the bearing area.

The damaged back plate was first machined down and “grooved” and then rebuilt with DurAlloy to the desired dimensions and contours. The plate was then coated with the DuraTough system to extend its service life.

On the pump shaft, the damaged area was undercut and threaded. DurAlloy was then applied and machined down after cure to the necessary tolerances.
