## Super Job on this Super Titan

ENECON's Australian Engineering Team came across this Super Titan pump at one of the largest copper mines in the world.

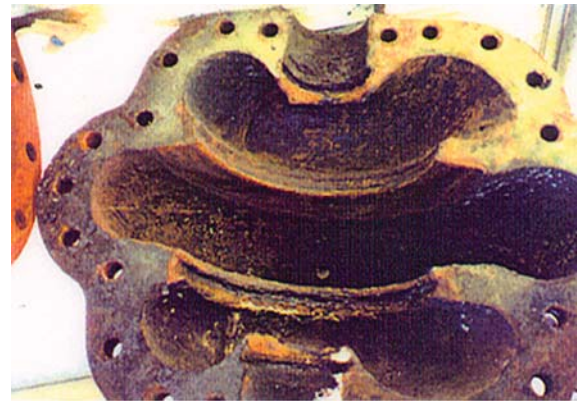
Severe erosion and corrosion from copper sulfate had taken its toll. So much so, in fact, that this **\$20,000 casing** was found in the **scrap heap!**

The photos clearly show the "picture perfect" results. And, the total cost of rebuilding - including multiple blastings, all labor, materials, reassembly, etc. - was **less than 25% of the replacement cost of the casing!**

The level of ingrained contaminant required grit blasting and "leaching" the casing **6 times** prior to any materials being applied. The wear ring areas required build-ups of 10 to 15 mm (about one-half inch) using **CP+**. Tolerances were especially critical since the plant required a running clearance of 0.005".

All the "wet areas" were then treated with **CeramAlloy CL+** to completely protect the casing from the accelerated attack it will be subjected to when returned to service.
