Nuclear Power Station Finds ENECON The Best Solution For Critical Shaft Repairs

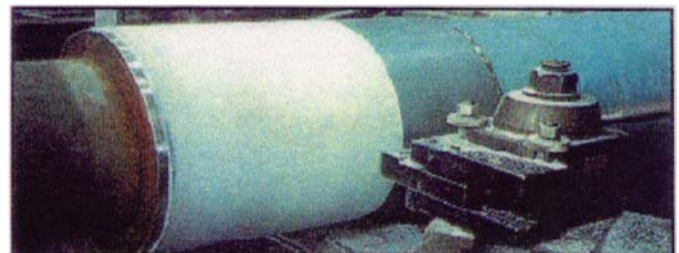
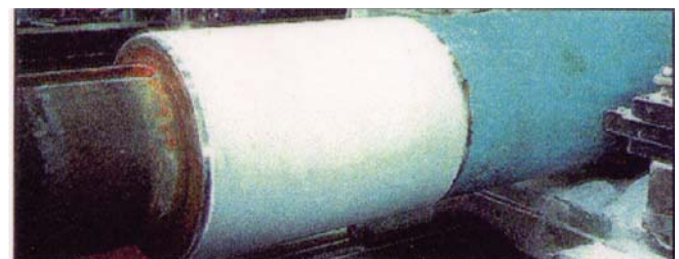
By using heat lamps to accelerate the cure, the DurAlloy could be machined after about one hour. The excess material was machined away - with the final pass of the cutting tool removing only a few thousandths of material, followed by polishing with an emery cloth to yield the desired finish.

DurAlloy was applied with the lathe turning slowly to draw the material from the applicator. The initial material was pressed in well, followed by additional DurAlloy to overbuild the surface and allow sufficient material for machining. Using the tape at the ends of the repair area as a guide, a straight edge was then used to insure that there were no low spots in the DurAlloy and also to leave a uniform overbuild to facilitate the subsequent machining operation.
