Plug Mill at Pottery Plant Handling Highly Abrasive Clay, Repaired & Protected With CeramAlloy

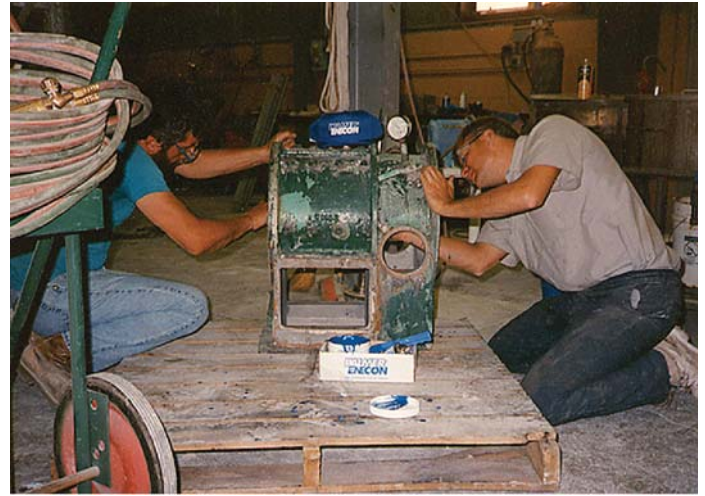
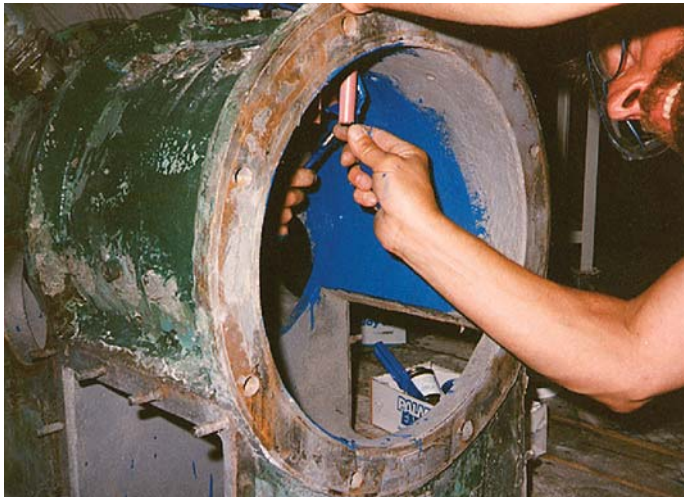
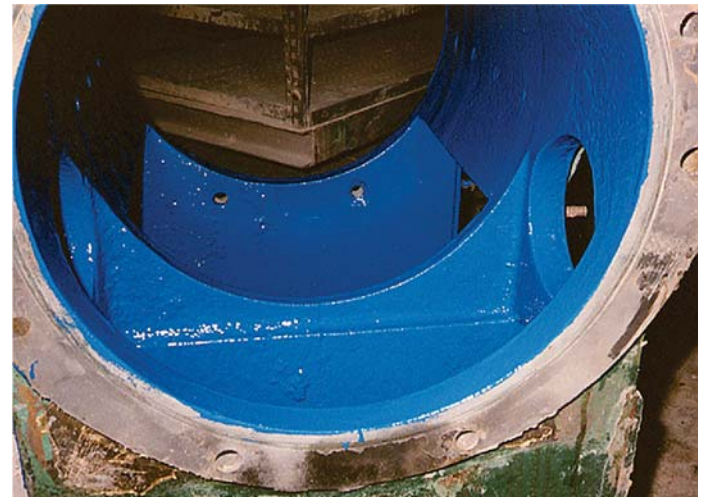
Highly abrasive clay wore the nickel plating inside this plug mill -- a type of

pump designed to remove air from clay. The clay is then extruded as a solid cylindrical plug.

Nickel contamination in the clay caused defective pottery when fired. The plug mill had to be shut down until the problem could be solved.

The local ENECON Fluid Flow Systems Specialist was called in for his expert advice and he immediately recommended ENECON CeramAlloy CL+ to resurface the damaged wear surfaces of the plug mill.

The application was

completed by the plant's own maintenance engineers and took just one day to complete.

Just \$600 worth of CeramAlloy was needed to repair the plug mill good as new -- maybe better!
