Pennsylvania Power Station Solves Severe Erosion/Corrosion Damage on Generator Cooler With CeramAlloy

A local ENECON Fluid Flow Systems Specialist based in the Pittsburgh area supervised the repair and refurbishment of an **Alterex Cooler** at a major power station in Western Pennsylvania.

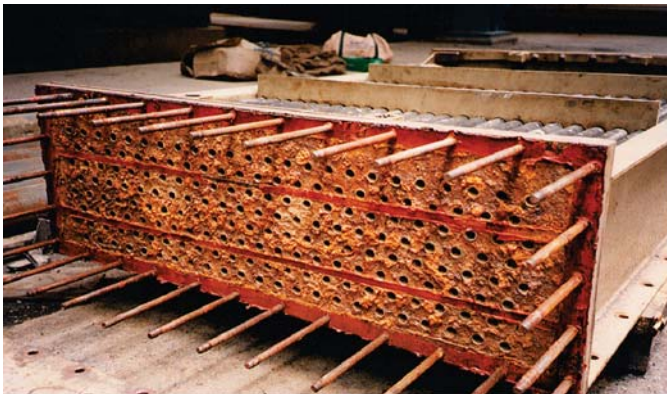
GE generators at the plant so when the extent of the erosion and corrosion damage to the cooler was discovered, a rapid repair procedure became very important.

The severely damaged cooler.

project which included thorough grit blasting and installing a ¼ inch thick build-up of CeramAlloy CP+ followed by a coat of CeramAlloy CL+ to provide a smooth finish to the tubesheet.

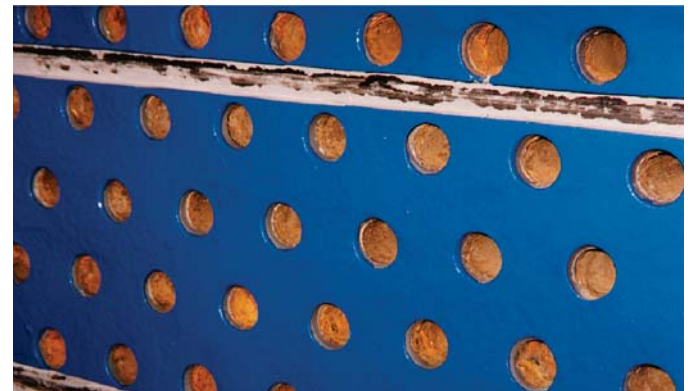
CeramAlloy CL+ applied to complete the project.
