California Refinery Reclaims Severely Damaged Salt Water Pump

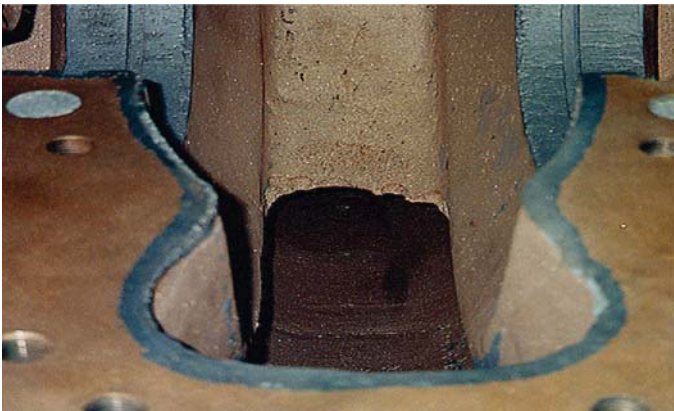
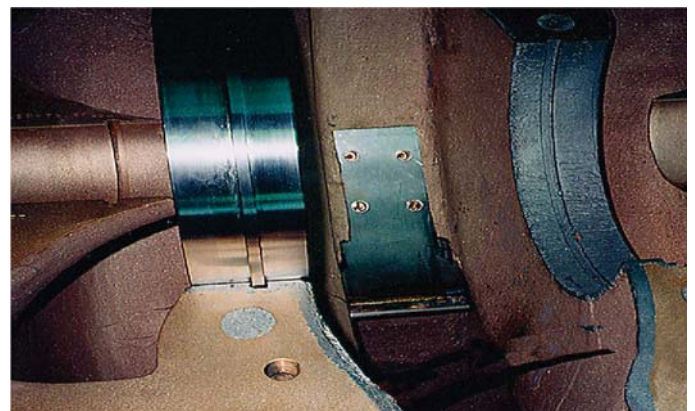
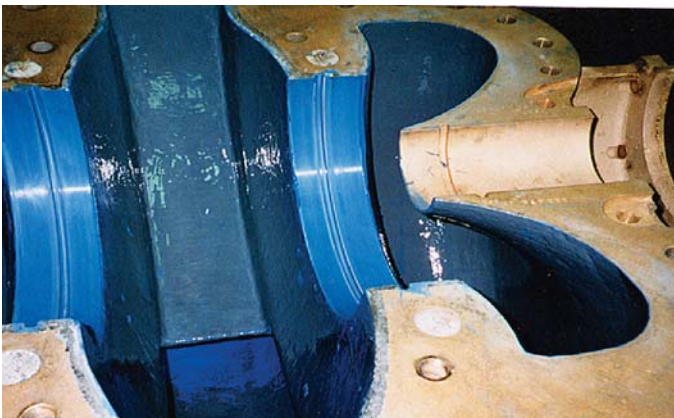
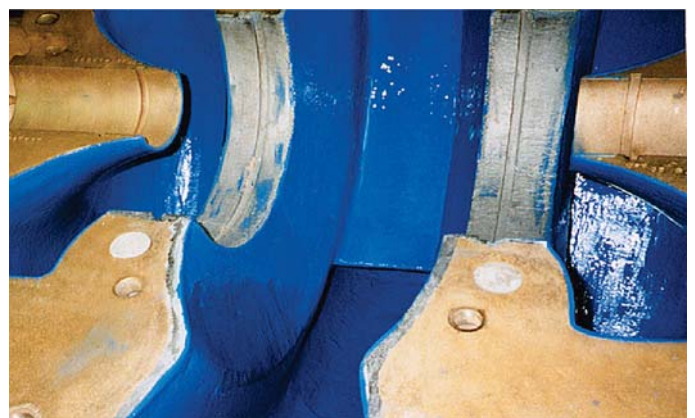
The cut water was found to be severely eroded. In addition, a previous coating in the pump had proven ineffective and was peeling off after being eroded and undercut by the seawater.

A new cut water was fabricated from stainless steel, and held

in place with CeramAlloy plus mechanical fasteners. All wet areas were then rebuilt and coated with the CeramAlloy system.

The CeramAlloy was also used to rebuild the ring seats - creating a perfect fit with the new rings - **without the need for machining.**
