Badly Worn & Holed Pump Casing at Major Paper Mill Repaired & Resurfaced With CeramAlloy

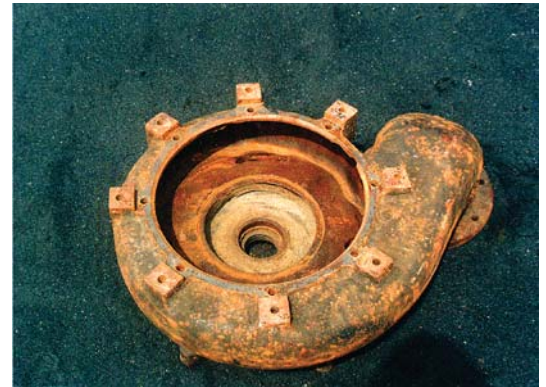
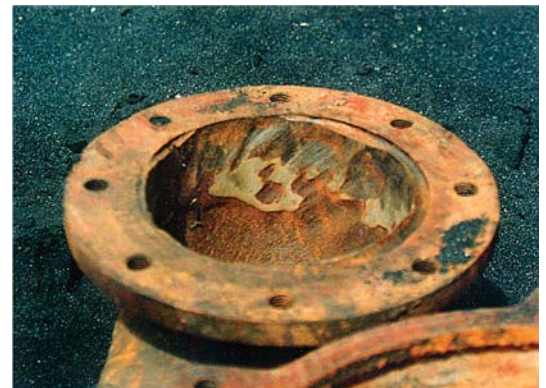
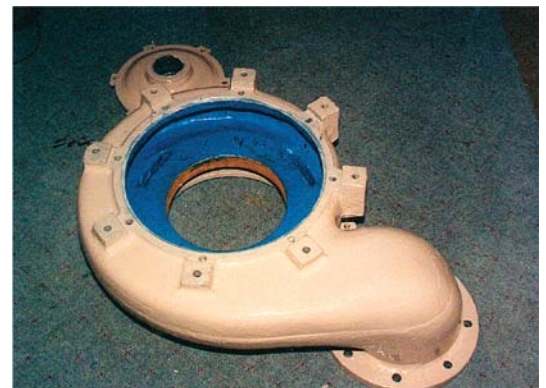
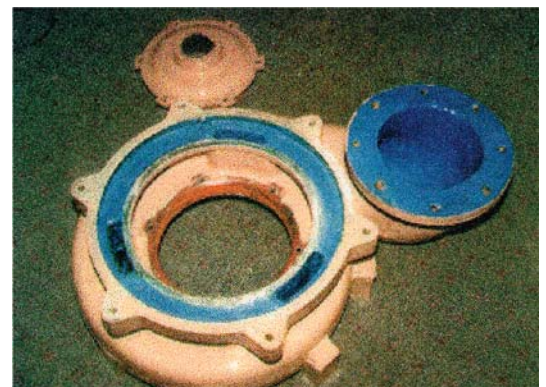
The plant engineers at a major pulp and paper mill in South Africa discovered a severe erosion and corrosion problem on their pump.

After thorough grit blasting, all eroded and holed areas were first rebuilt with CeramAlloy CP+, and then two coats of CeramAlloy CL+ liquid ceramic were applied to all wet

areas in order to protect the pump from future erosion/corrosion attack.
