Los Angeles Utility Saves Thousands of Dollars on Transformer Leak Repairs

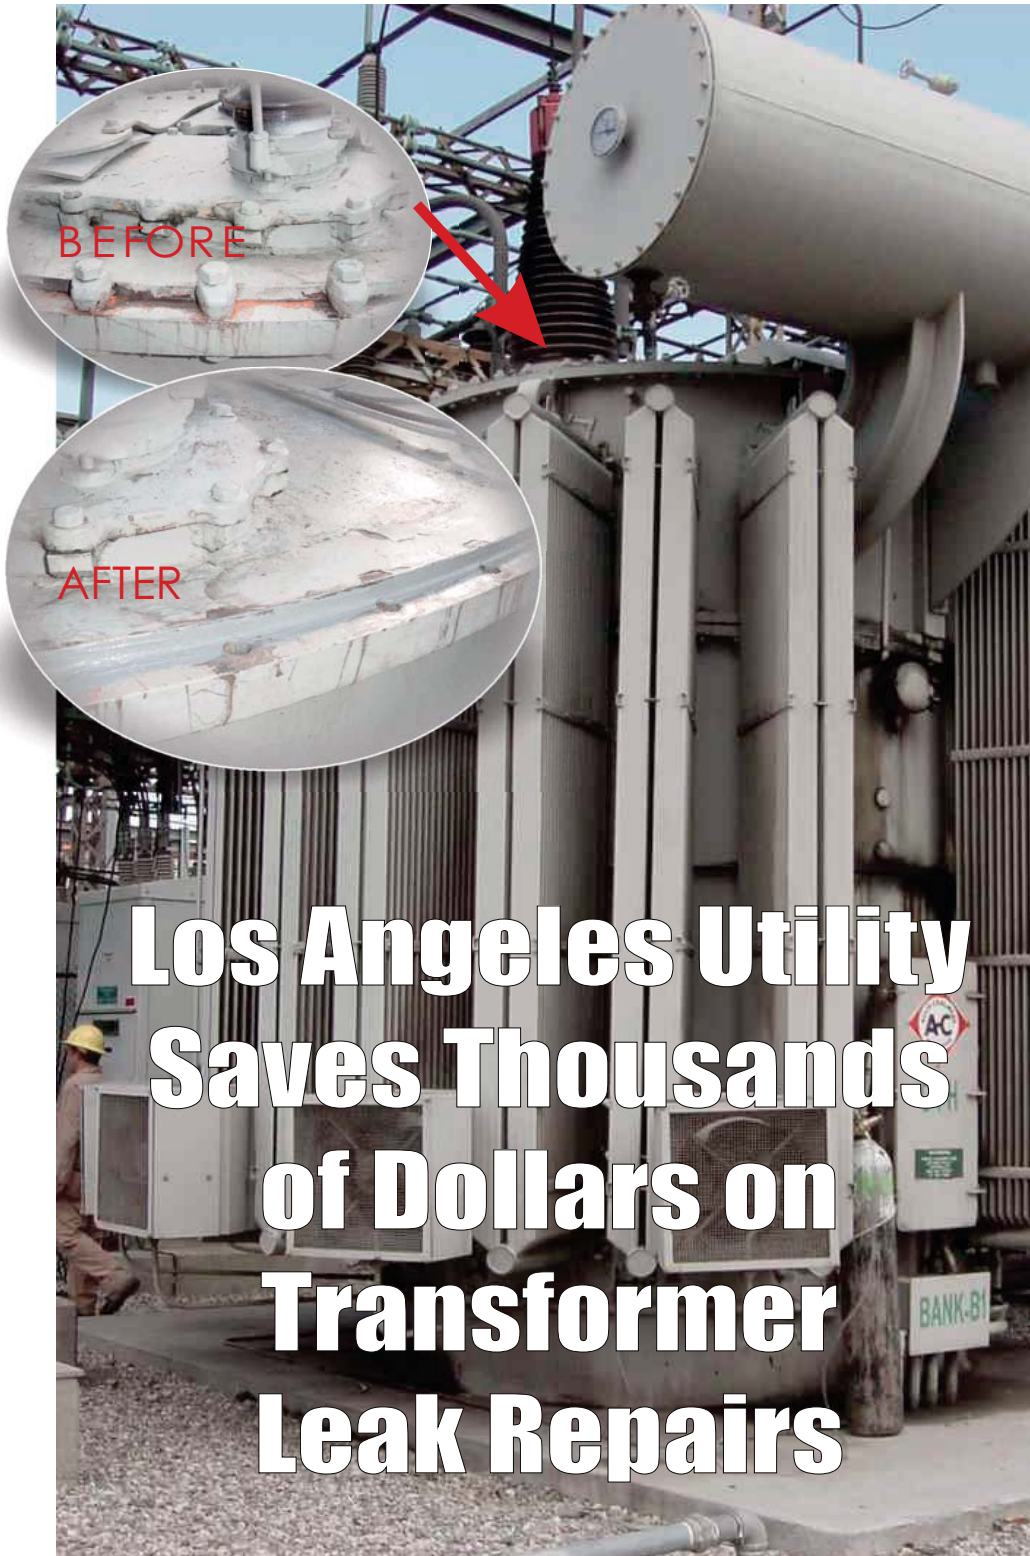
The top flange of this large transformer at a local Southern California electrical utility substation was leaking oil. The nitrogen blanket that normally covers the transformer oil rarely requires re-charging. However, due to the steady leaks, the utility had to hook up nitrogen cylinders to the transformer in order to maintain the nitrogen blanket over the oil.

The utility evaluated three options: (1) drain the tank, remove the flange and replace the gasket; (2) remove the oil and weld the flange; or (3) repair and seal the leaking gasket with METALCLAD DurAlloy. The first two options would have cost the utility many thousands of dollars, but the DurAlloy repair would require only about \$500 worth of material and a couple of man-days of labor. The choice became simple: DurAlloy provided the long-term, cost-effective repair option.

Under the guidance of Ray Williams, ENECON's Regional Sales Director, six bolts were removed at a time and the area was thoroughly cleaned and degreased (old paint was removed). DurAlloy was then properly mixed and applied to the seal area. The bolts were then replaced. This procedure took a couple of days to complete but now the transformer, installed in the 1960's, is leak-free. The utility has already purchased additional DurAlloy to seal more transformer leaks at their other substations.
