## UK Refinery - One of the Largest in Europe - Salvages Badly Eroded/Corroded Pump With CeramAlloy & DuraTough

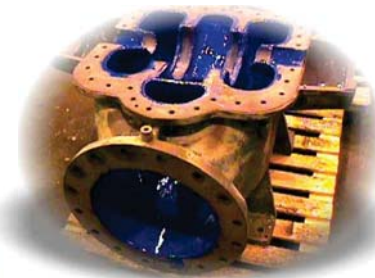
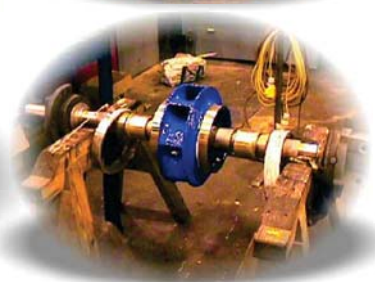
*The pump impeller and bottom casing after 9 months continuous duty, showing the DuraTough DL protection of the impeller surface is still in good condition.*

Inspected after 9 months in service, the rebuilt pump was shown to be in excellent shape and continues to perform perfectly.
