## U.S. Aircraft Carrier Seals Leaking Hatches on Flight Deck

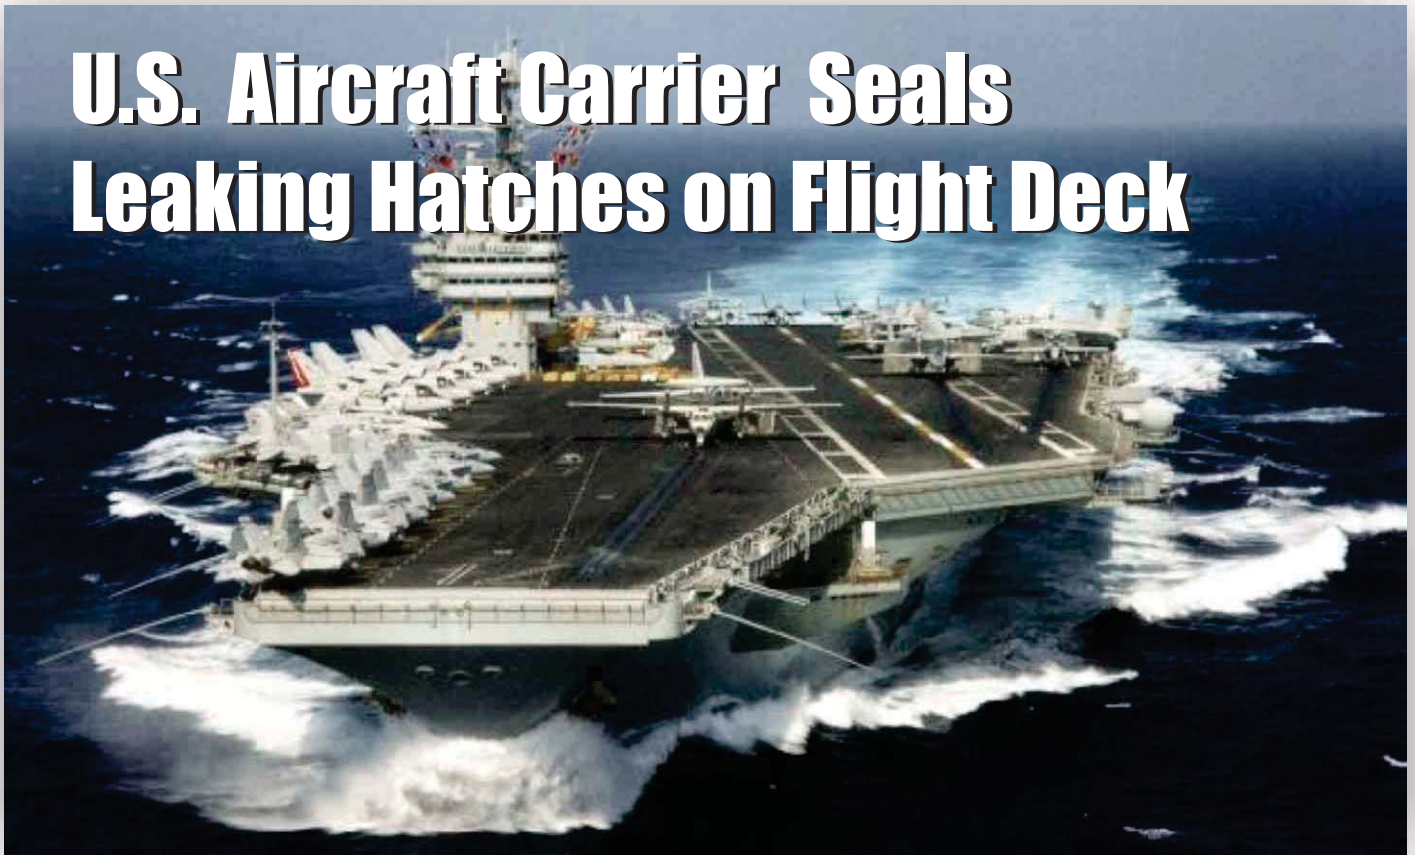
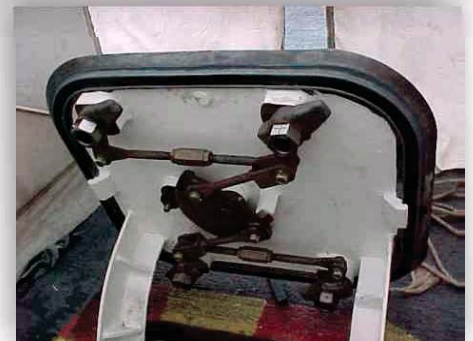
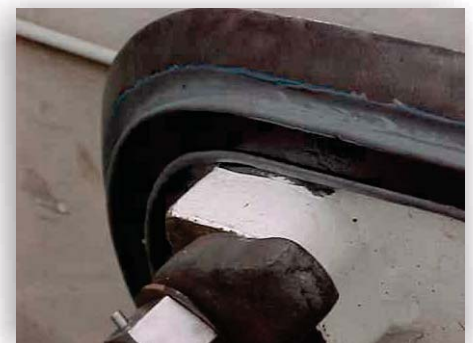
The Auxiliary Electric Start Systems (AESS) lockers on an aircraft carrier provide the ability to “jump start” a fighter plane if required. The hatches are flush with the carrier deck and are designed to keep water and other contaminants from getting into these lockers – potentially compromising the operation of the electrical systems.

What often happens, however, is the gasket retainer corrodes due to constant immersion in saltwater, fuel, hydraulic fluid, etc. As a result, the hatches leak and the AESS lockers can fill with water. This is not a good thing.

A conventional welding repair is time-consuming and sometimes damages the hatches. The ship’s engineers decided to utilize a

more “high-tech” approach. The damaged areas were repaired with DurAlloy then sanded smooth to the desired shape and dimension. Two coats of CeramAlloyCL+ [AC] were then applied over the entire seal area to provide long-term corrosion protection to these hatches.
