## Largest US Gold Producer Repairs Heat Exchanger With CeramAlloy

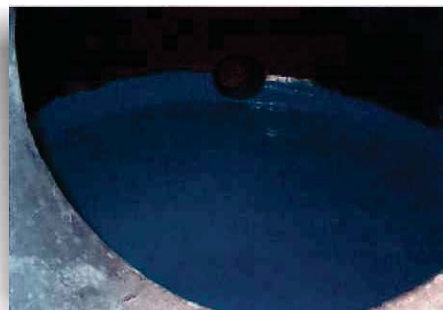
**Water box repaired & coated**

the situation and recommended a standard high-build CeramAlloy cladding system to rebuild and protect the 9-foot diameter, lead tube sheet and the steel water box.

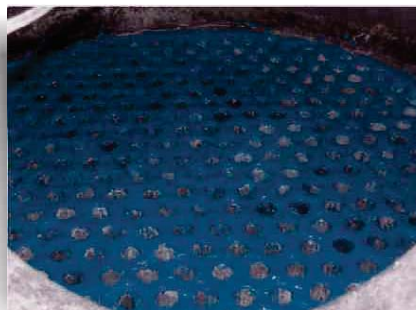
**Tube sheet repaired & protected**

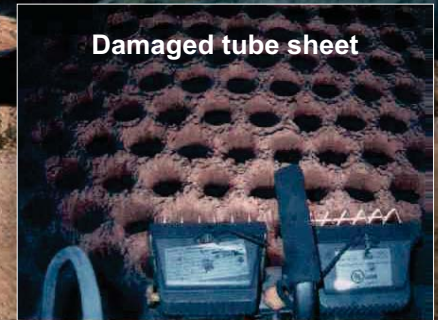
The mine's engineers were experiencing an extremely high amount of erosion to the lead tube sheet

of their gas cooler in the refractory ore treatment plant. The flushing solution in the cooler – used to keep the tubes clean – has a very erosive effect on the lead tube sheet surface. This solution contains suspended solids and elemental mercury. The ENECON Team from S & G evaluated

**Damaged tube sheet**
