CeramAlloy Repairs Salt Water Filter at Major Spanish Natural Gas Company

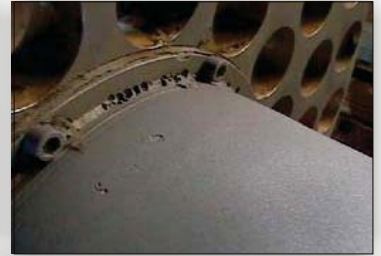
This portable, self-cleaning salt water filter was showing deep surface corrosion due to biological and organic debris.

After protecting the mechanical areas, the surface was prepared by grit blasting.

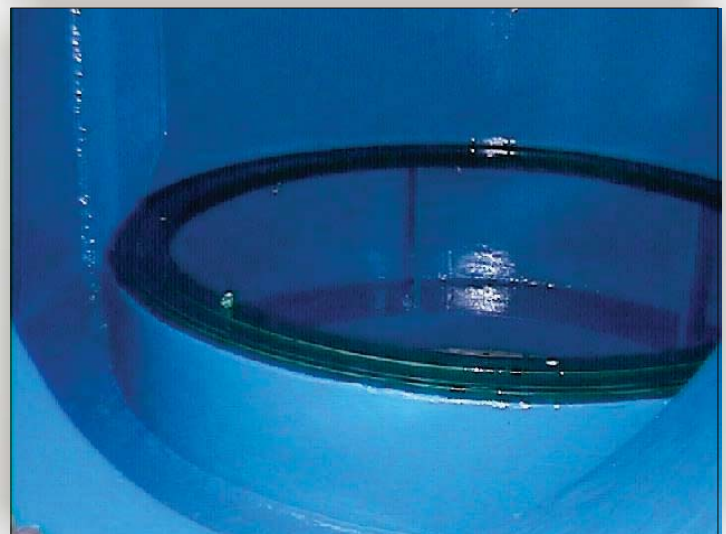
After this repair was completed, the engineers agreed that a flexible joint at the bottom of the filter would be needed.

So FLEXICLAD DuraTough DL was applied to create a durable, yet flexible seal.
