CeramAlloy Repairs and Protects Wicket Gates at Spanish Hydroelectric Power Station

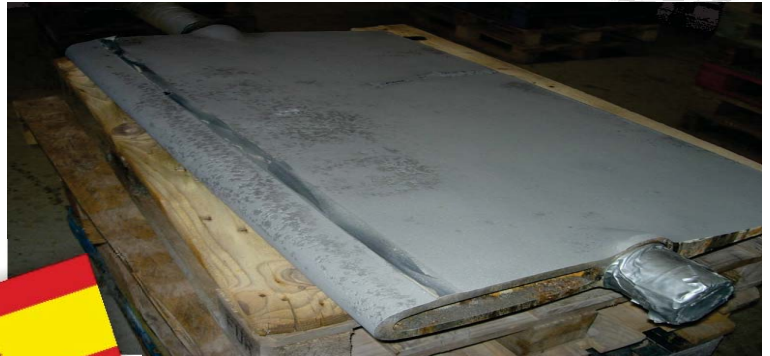
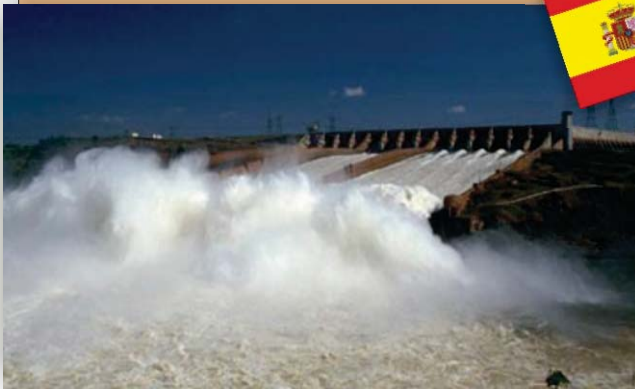
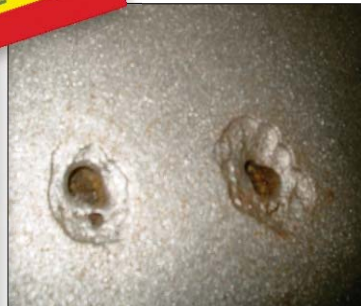
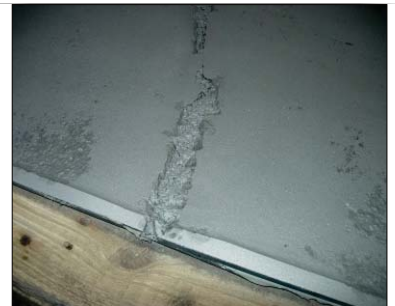
One of Spain's largest hydroelectric power stations was experiencing erosion and corrosion on its turbine wicket gates.

The station's engineers attempted to solve this problem by welding, but to no avail. Erosion damage was returning and deeper than before.

Upon review of the situation, it was recommended that the erosion damage (pitting) on the wicket gates be rebuilt with CeramAlloy CP+AC, followed by two coats of CeramAlloy CL+AC.

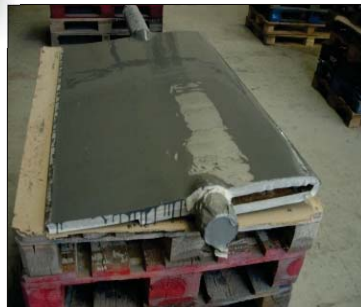
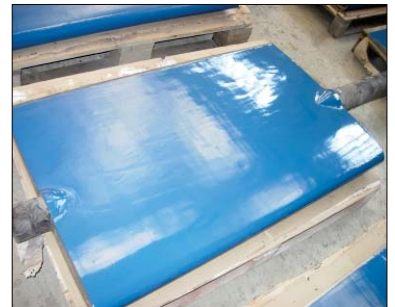
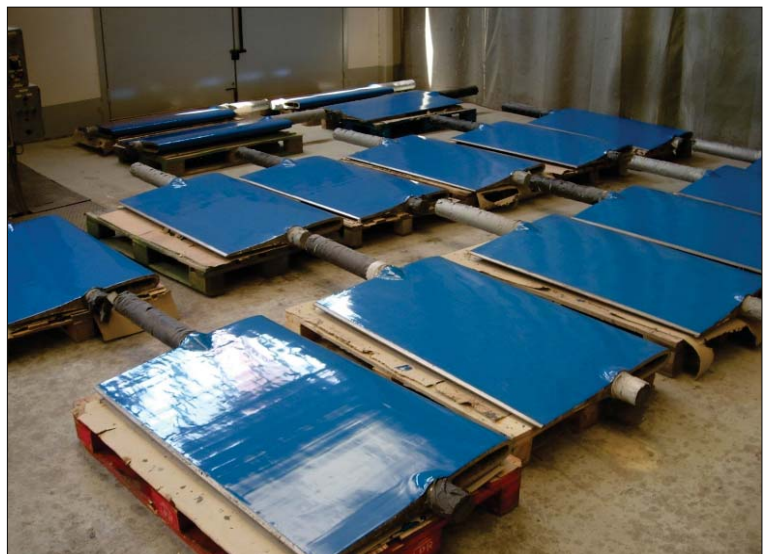
After the turbine wicket gates were repaired and resurfaced, the result was a smooth surface that is more erosion and corrosion resistant than the original metal.
