## Spanish Nuclear Plant Uses CeramAlloy to Repair & Protect Cooling Tower Pumps

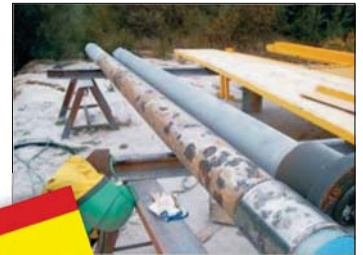
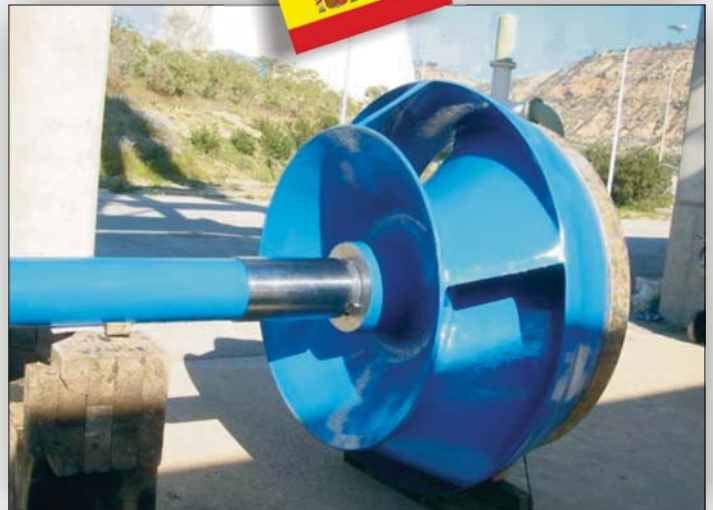
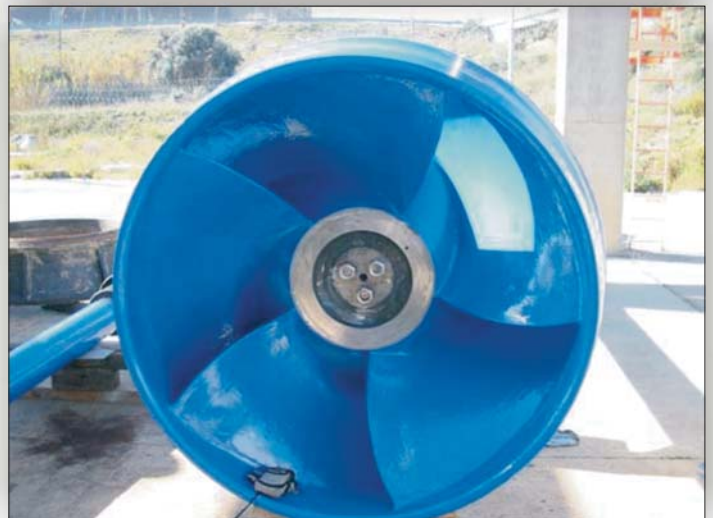
An important Nuclear plant in Spain had been experiencing erosion and corrosion on four pumps that supplied water to their cooling towers.

To repair the pumps the surfaces were grit blasted.

CeramAlloy CP+ was first applied to repair any damaged areas. That was then followed by an application of CeramAlloy CL+ for protection against further erosion and corrosion.
