Spanish Nuclear Station Chooses CeramAlloy & DuraQuartz To Control Corrosion On Cooling Water Intake Lines

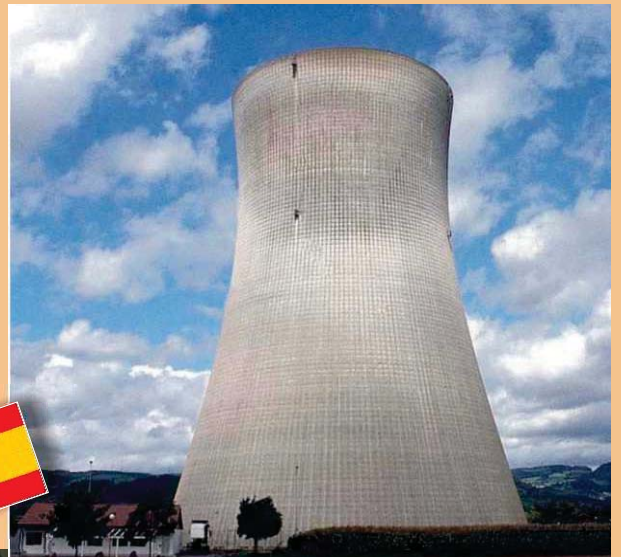
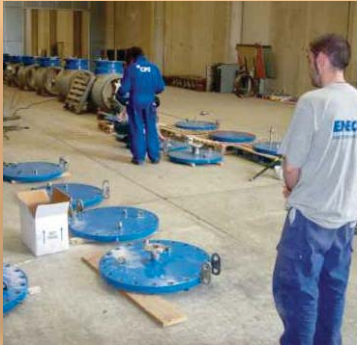
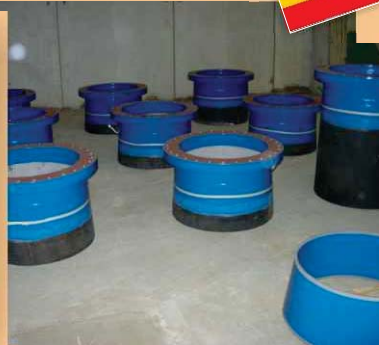
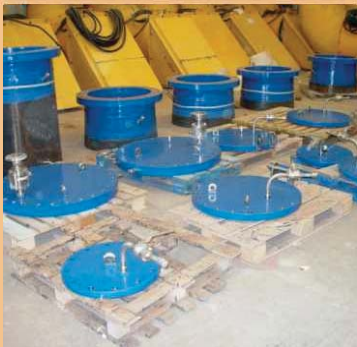
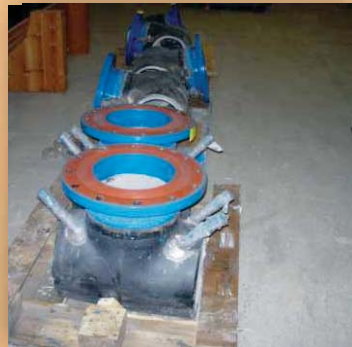
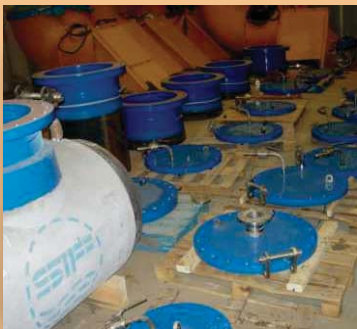
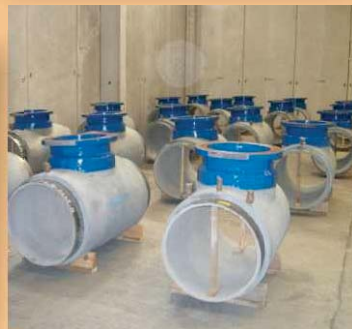
The maintenance engineers of this major nuclear power station were experiencing problems in their cooling water intake lines due to ineffective seals on the access manhole collars. The metal intake piping is encased in concrete and the existing design was allowing water to seep between the concrete shell and the metal core. This caused corrosion on the outside of the metal pipe.

The local ENECON Ibérica specialist recommended building up the joint between the metal collars and the concrete casing with DuraQuartz to prevent the water from getting behind the seal. After the DuraQuartz was applied, the collars were coated with two layers of CeramAlloy CL+(AC) to complete the application.

Upon reassembly, the station engineers were completely pleased when they saw that the leakage had been stopped and the corrosion problem eliminated.
