German Wastewater Treatment Facility Selects DurAlloy & CHEMCLAD To Repair Large Vertical Spiral Cage Pump

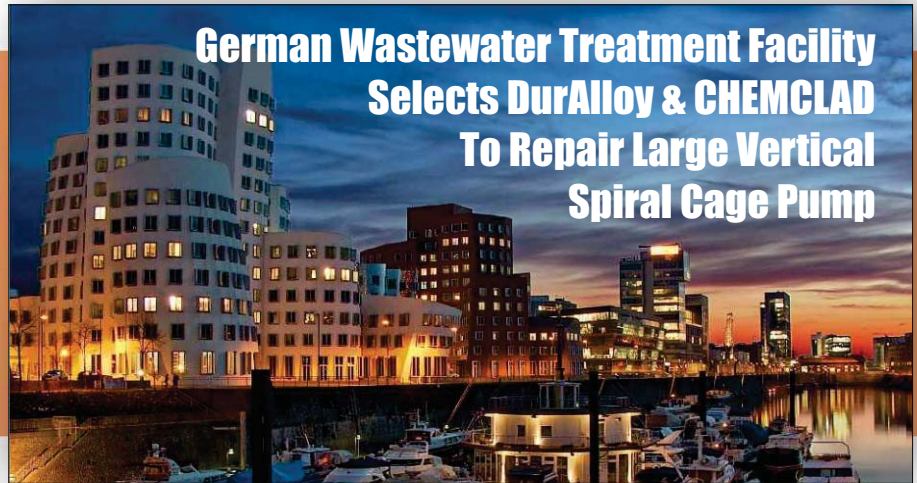
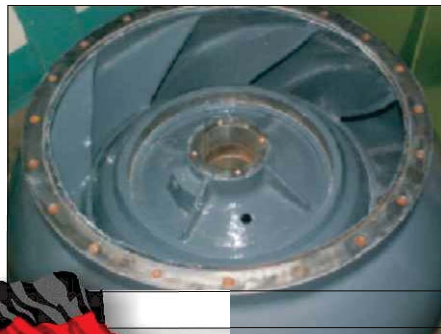
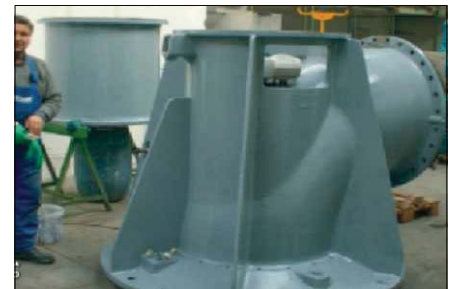
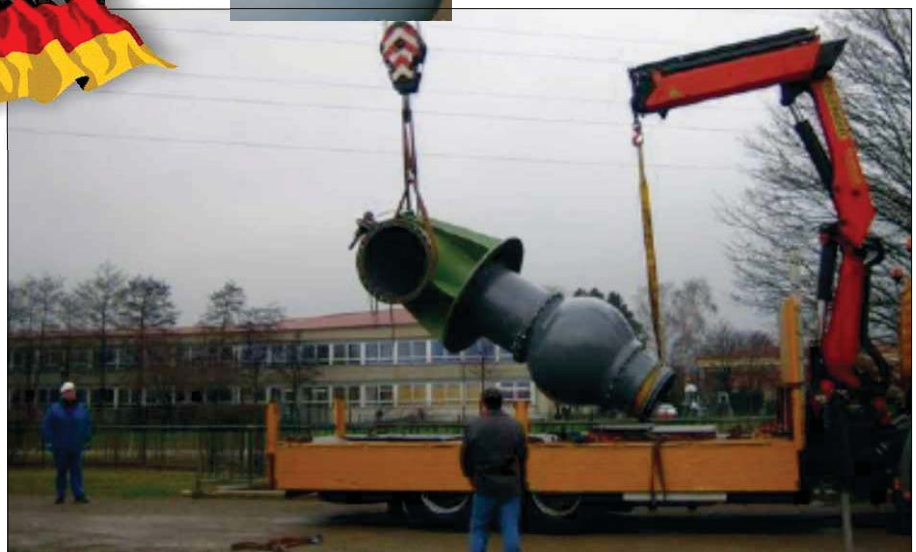
A major German wastewater treatment facility had experienced some corrosion damage on the guide veins of a large vertical spiral cage pump. The guide veins of the housing were severely damaged after some concrete blocks were accidentally left in the intake duct following some repair work.

NovoTech, the local ENECON Distributor in Germany, was called in to find a solution to this serious problem. It was decided that they would re-build the edges of the guide veins of the pump with DurAlloy. To enhance the strength of the DurAlloy, hexagonal screws were driven in to the edges of the damaged guide veins. Then DurAlloy was used to build up the edges.

After the DurAlloy had cured, the edges of the guide veins were ground to restore their original shape. The rest of the pump was then grit blasted both inside and out. Following the grit blasting, two coats of CHEMCLAD SC were applied. The inlet elbow of the pump was then painted green to match the color code of the facility.
