## Main Paper Feed Stock Pump Repaired & Resurfaced With CeramAlloy & CHEMCLAD

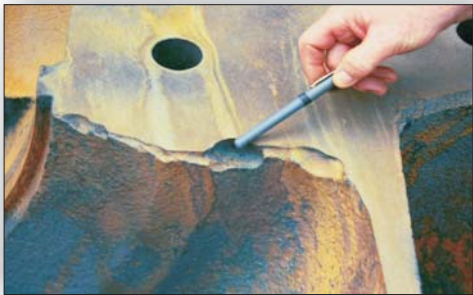
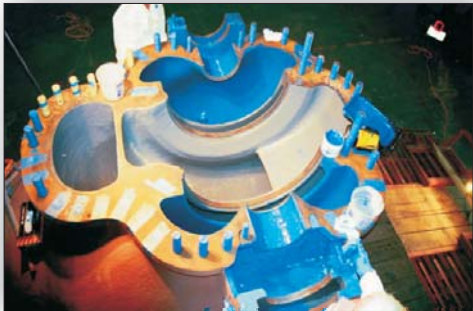
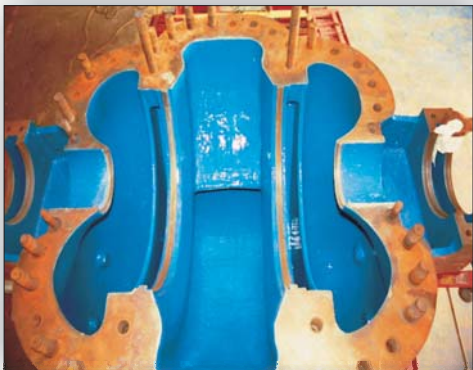
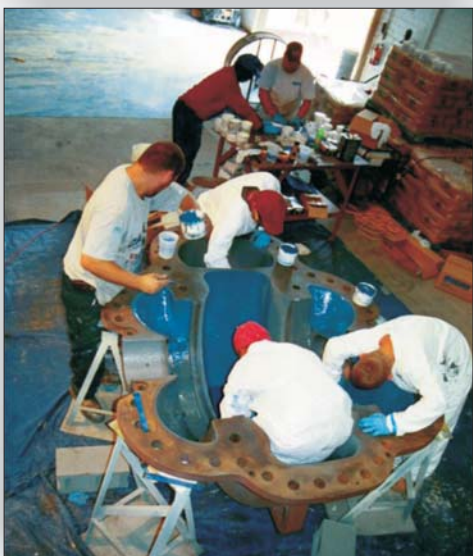
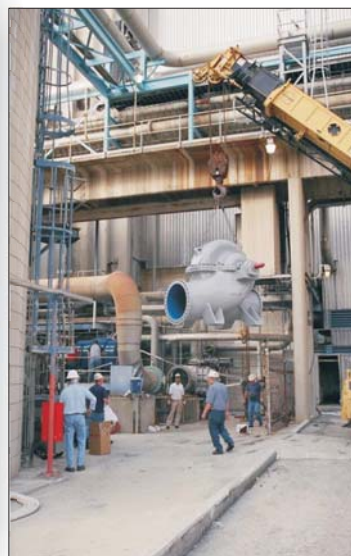
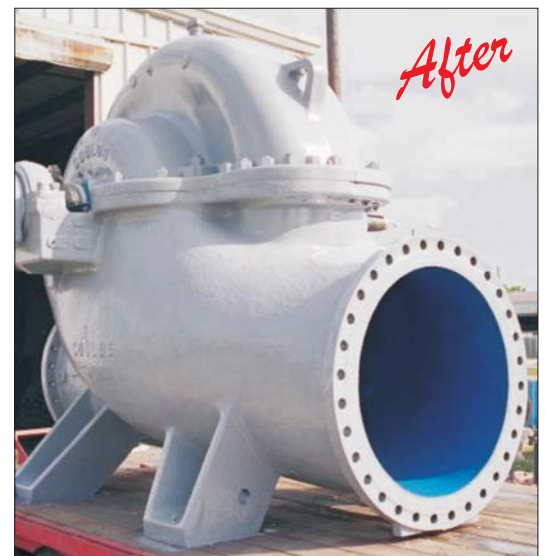
The plant engineers at this large paper mill located in North Carolina needed a cost effective and commercially proven repair solution for their 30-year old main paper feed stock pump which was severely eroded and corroded.

They suggested that all internal surfaces be repaired and resurfaced with CeramAlloy CP+AC and CL+AC. They then recommended that two coats of CHEMCLAD SC be used to protect all external surfaces from the aggressive paper mill environment.

This major project was successfully completed in just one week.

Since the plant has maintained detailed records of the pump's operation over the years they determined that the rebuilt and resurfaced pump was actually performing *more efficiently* than when it was first installed.
