CeramAlloy Solves Cathodic Corrosion Problems On This Auto Ferry

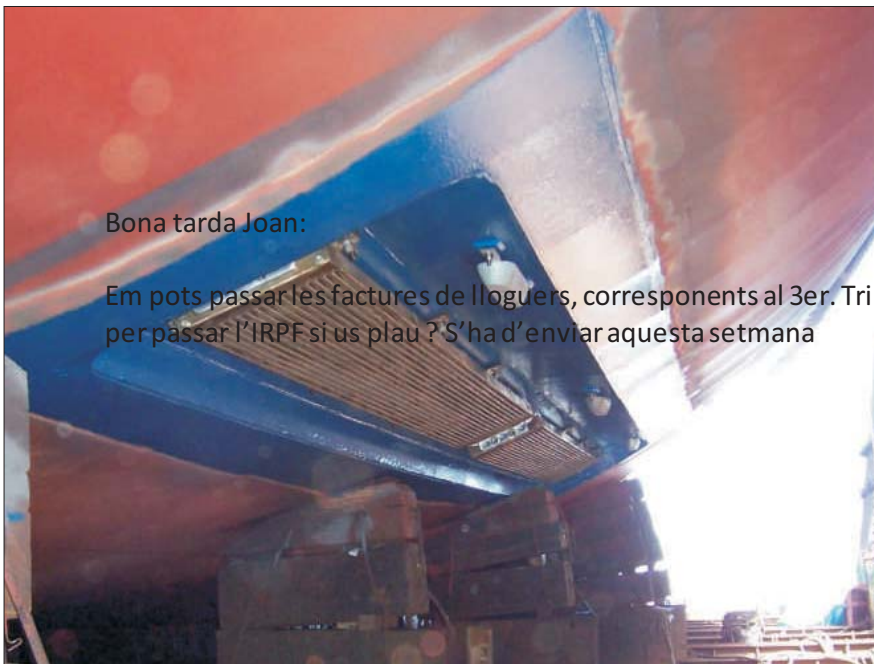
This large auto ferry had been experiencing severe cathodic corrosion damage in the keel cooler pockets. The ferry's engineers were unable to maintain proper cathodic protection with standard solid anode installations.

The ferry's rudders were also suffering from

erosion and impact damage.

The local ENECON Field Engineering Specialist recommended Metalclad **CeramAlloy** as a solution.

After extensive preparation of the keel cooler pockets which

included grit blasting, a three-coat **CeramAlloy CL+AC** system was applied. The forward section of the rudders as well as the stern tubes were also coated.
