Major International Chemical Company Turns to ENECON for Help in Solving Serious Corrosion Issues

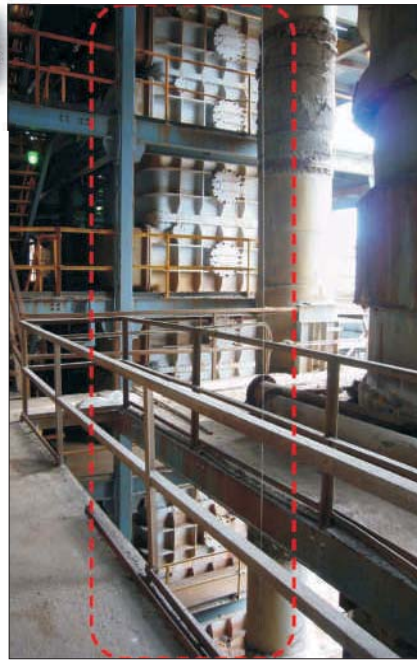
This 20-year-old preheater located at a soda ash manufacturing plant in India had been suffering from severe chemical attack and erosion damage.

ENECON India was contacted to help find a solution to this problem as well as to protect this preheater from future corrosion damage.

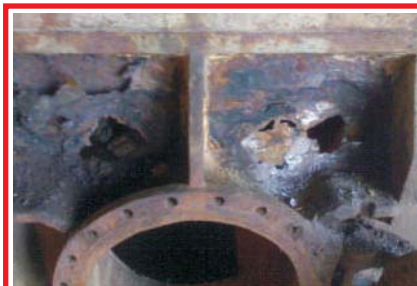
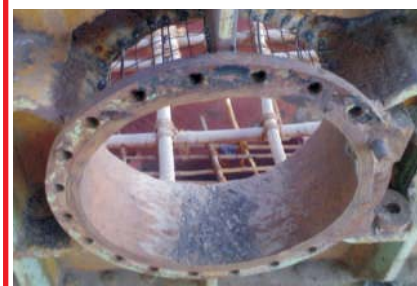
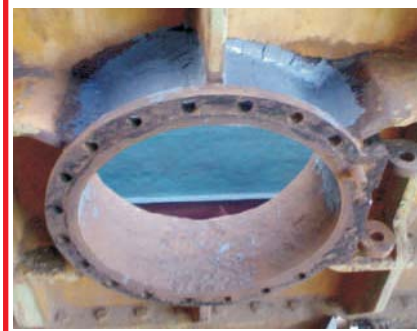
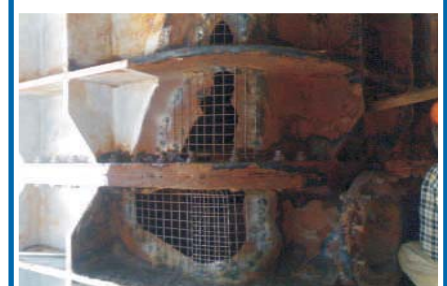
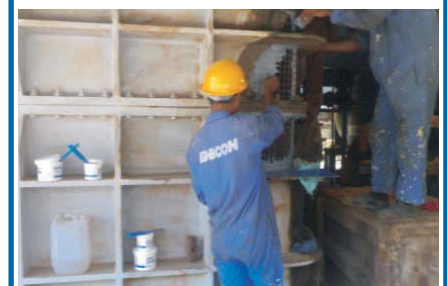
When the surfaces were grit blasted, large holes in the steel were uncovered and these had to be repaired immediately. Welding was not possible due to the potential for further damage to the thin metal surfaces. The ENECON field engineers, therefore, recommended an unconventional repair procedure: stainless steel wire mesh was used to bridge the large holes in the steelwork and **DurAlloy** (224 kg.) was used to permanently repair these areas.

After all holes were repaired, 2 coats of **ENESEAL CR** (280 kg.) were used to protect all of the exterior surfaces from the aggressive environment at this facility.

The plant's management was extremely satisfied with the outcome of this project. This preheater was put back into service immediately and preparations are being made to repeat this repair/protection project on another of the plant's preheaters.
