CeramAlloy CBX Outperforms Rubber Liner & Hardface Welding

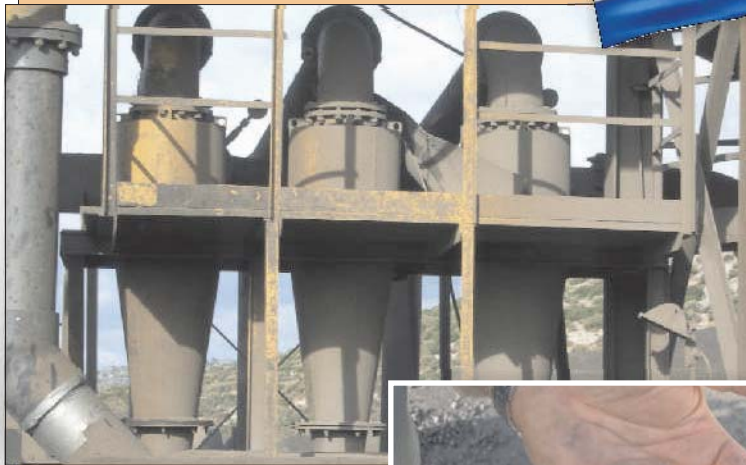
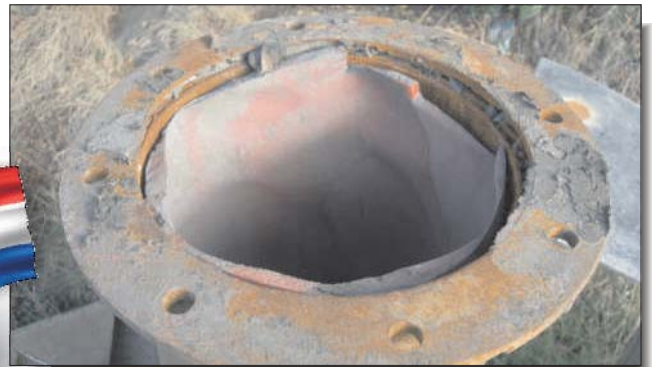
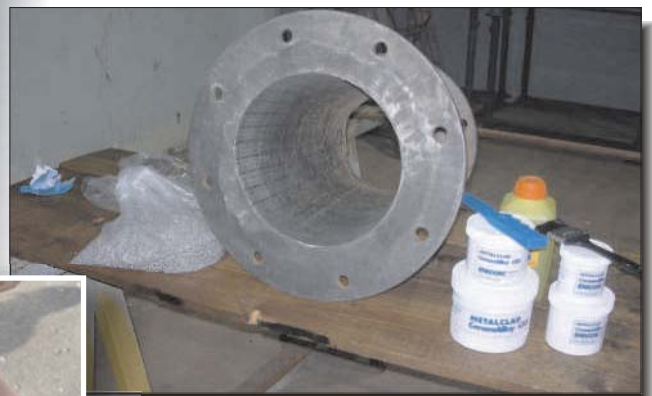
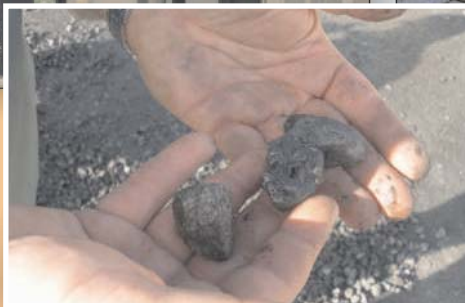
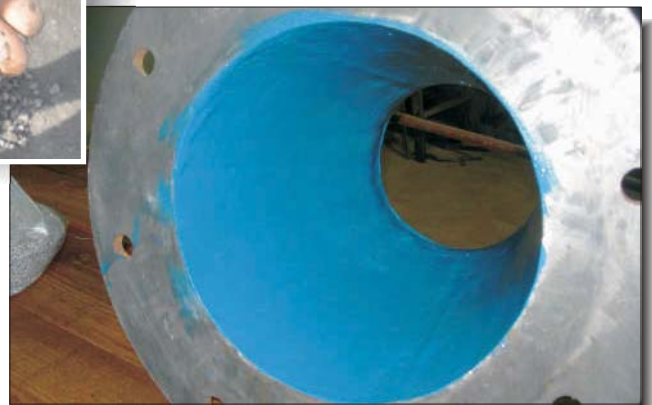
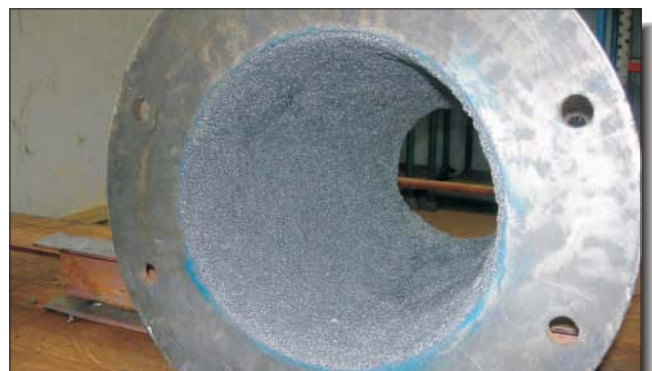
The plant engineers wanted to see if they could find a more durable repair material so they conducted a side-by-side test utilizing a rubber liner for one

cyclone, hardface welding on another and CeramAlloy CBX on a third cyclone.

After three weeks the rubber liner and the hard-facing had both failed but the CBX was still providing excellent protection. The engineers selected our CBX as their standard repair material for this demanding application and immediately coated three additional spare cyclones.
