Major Power Plant Located in the Northeastern U.S. Selects CeramAlloy Pipe Wrap System to Repair this Main Cooling Water Intake Pipe

The maintenance engineers at this large oil fired power plant needed an unconventional approach to repairing and reinforcing a damaged section on one of their main cooling water intake pipes.

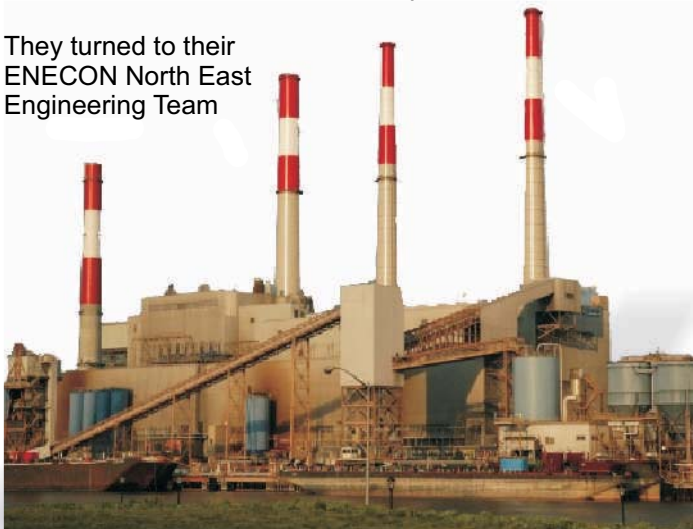
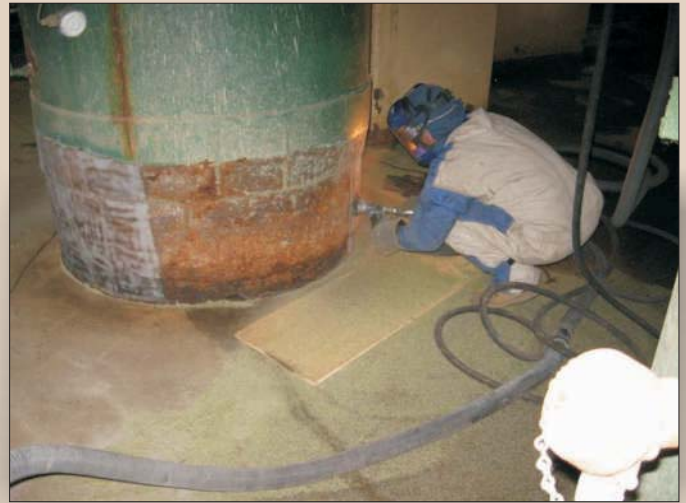
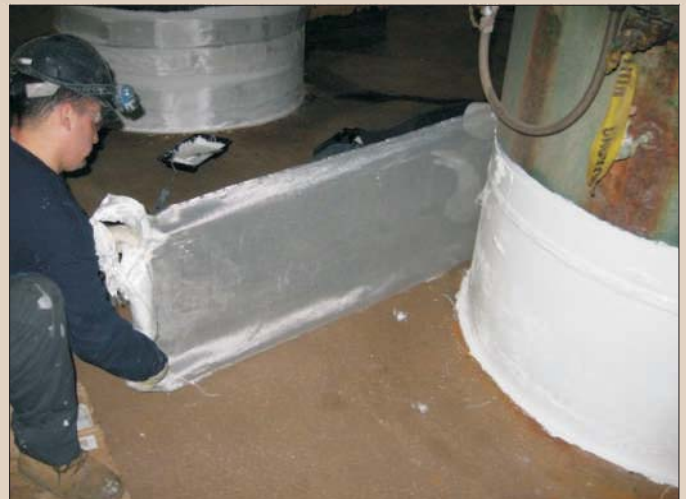
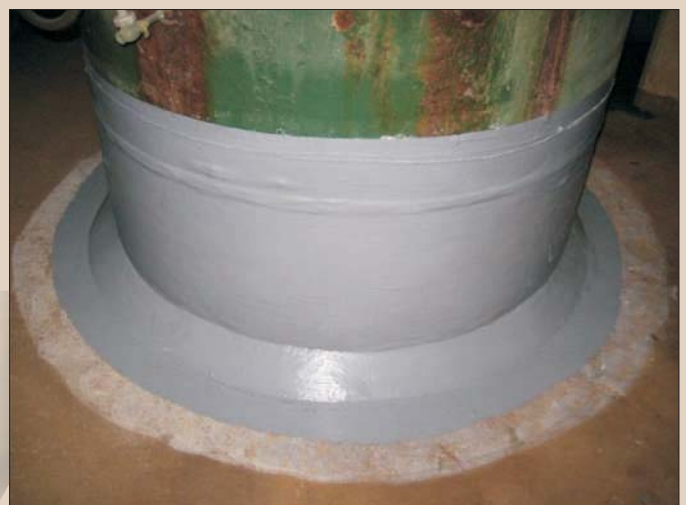
They could not shut down the plant for an extended replacement procedure and they were concerned that a conventional welding repair could damage the pipe further since it was already worn thin by years of erosion and corrosion attack in the brackish water environment.

After preparing the surface by grinding and wire-brushing, **SuperBond** was applied to insure optimum adhesion. This was followed by the application of multi layers of **CeramAlloy** and special reinforcement cloth to completely encapsulate this pipe section, thus providing a long-term repair. This \$10,000 project took just a couple of days to complete.
