California Power Plant Salvages Main Cooling Water Inlet Pipes with a CeramAlloy Pipe Wrap System

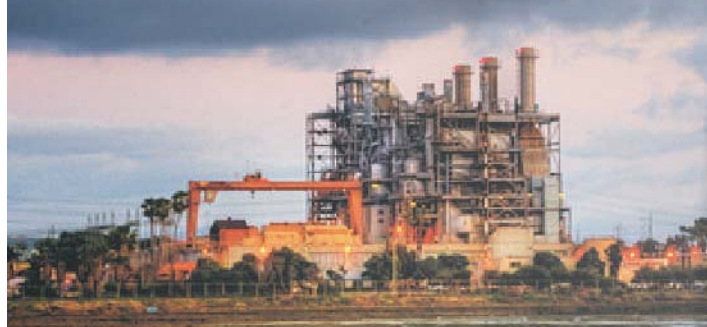
The engineers at this large power station in California identified a serious problem with their two main cooling water inlet pipes which were severely corroded due to many years of operation in a coastal marine environment.

After first grit-blasting these 4-foot diameter pipe sections, any serious corrosion

damage - including a number of actual holes in the pipes - was first repaired with DurAlloy and metal plates.

A layer of **CeramAlloy CL+AC** was then applied over the entire pipe section followed by a spiral wrap of a special reinforcement fabric. This was then completely encapsulated by an additional two layers of CeramAlloy CL+AC to complete the pipe wrap system.

This procedure was completed in just a few days and at a fraction of the cost that would have been incurred to replace these large pipe sections.
