CeramAlloy 'Rescues' Italian Passenger Ferry Thruster Tunnels

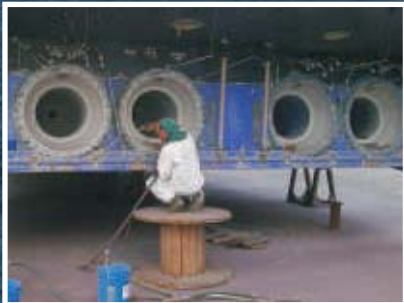
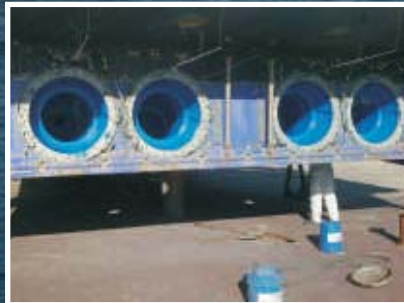
Before

The owner of an Italian passenger ferry fleet had been experiencing corrosion damage on the aluminum thruster tunnels on one of his ships.

Several attempts to repair and protect these tunnels were made using conventional coatings. These failed after only three months!

ENECON Italia was contacted to help find a cost effective, yet long-lasting solution. After first preparing these tunnels, CeramAlloy CP+AC

was used to repair all pitted surfaces, followed by 2 coats of CeramAlloy CL+AC to provide long-term protection.

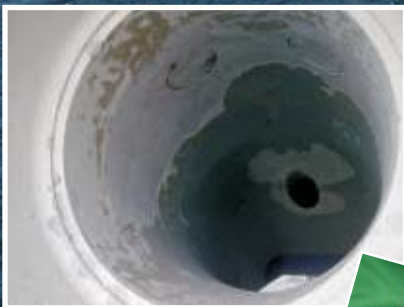
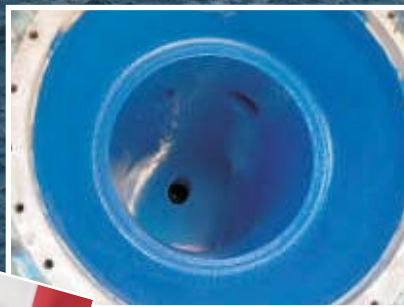
After 1 year, during routine maintenance, it was discovered that the CeramAlloy was in excellent condition and needed only minimal spot repairs due to physical damage.
