Croatian Navy Uses CeramAlloy to Repair and Protect Propeller Shafts

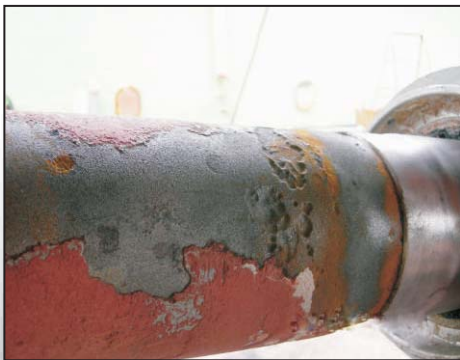
The propeller shafts on this Croatian Naval ship were suffering from severe erosion / corrosion in the areas around the struts and before the propellers. This was due to many years of operation in a harsh salt water environment.

ENECON Croatia was contacted and it was recommended that a combination of CeramAlloy CP+AC and CL+AC be used to repair the existing erosion / corrosion damage and to protect against future damage.

CeramAlloy CL+AC were then applied.

After first grit blasting the damaged areas, a layer of CeramAlloy CP+AC was applied to rebuild the damaged areas. Two final coats of

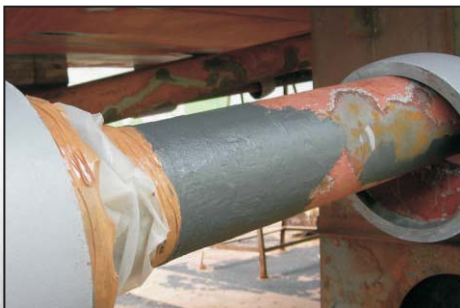
Previously applied epoxy coatings had failed and the ship's engineer was looking for a long lasting, cost effective solution.
