DurAlloy & ENESEAL CR Salvage Fume Extraction System at Canadian Steel Mill Saving \$100k & Reducing Emissions

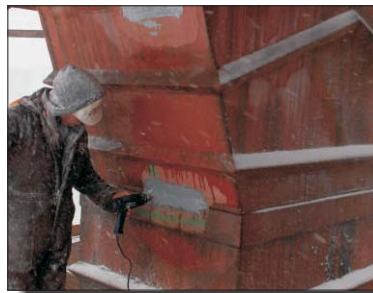
SpeedAlloy being applied.

ENECON Ontario was contacted to help find a fast and long lasting solution. Test patches of *SpeedAlloy* were applied to some of the duct's larger holes. The mill's engineers were so pleased with the results of the test patches it was decided that the entire duct section be encapsulated with

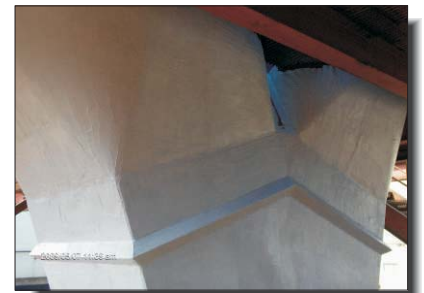
DurAlloy applied over entire extractor shell.

DurAlloy. As a final measure the unit was coated with *ENESEAL CR* for optimum corrosion resistance and a uniform look.

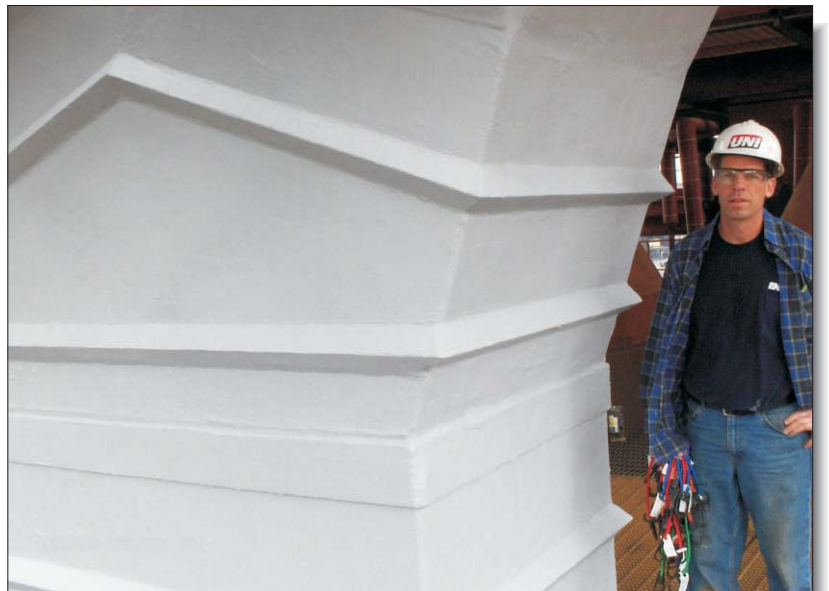
After totally encapsulating the unit in DurAlloy, ENESEAL CR was used to provide optimum corrosion resistance and a uniform look.
