Mexico's Largest Petrochemical Company Specifies METALCLAD CeramAlloy for Repairs to Heat Exchanger Tube Sheets

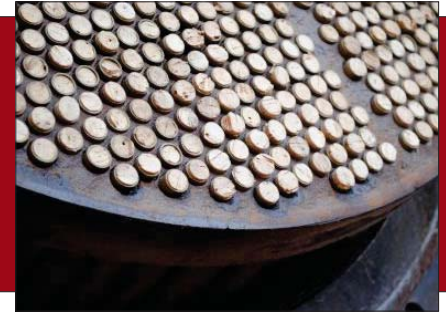
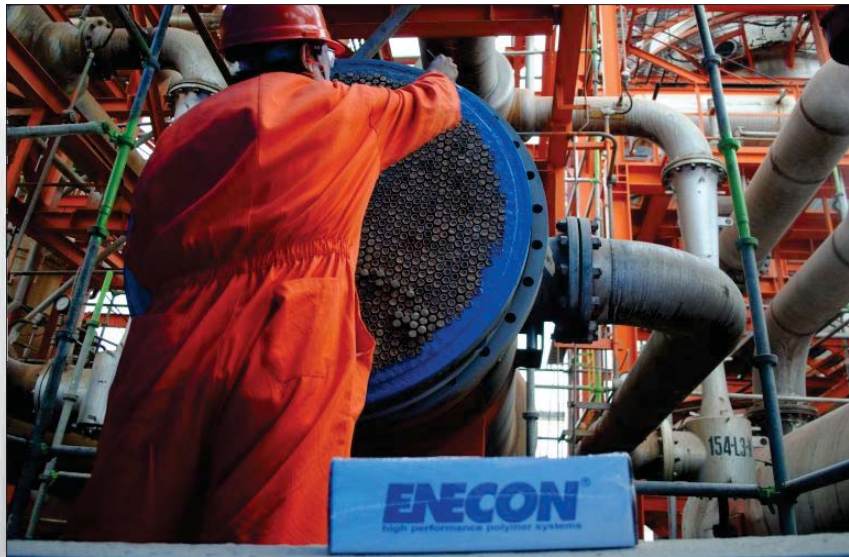
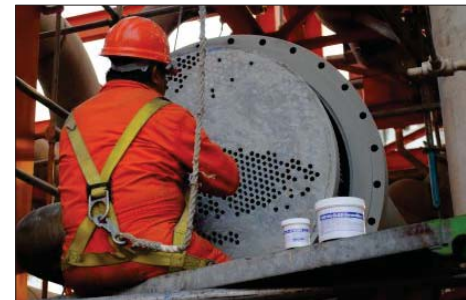
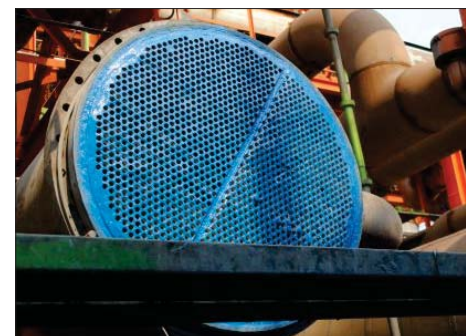
- Client:** Petrochemical Plant
- Location:** Mexico
- Problem:** Severely corroded heat exchangers.
- Solution:** Grit blasting followed by CeramAlloy CL+AC, CeramAlloy CP+AC and final top coat of CeramAlloy CL+AC.
- Savings:** The ENECON solution approximately saved around 90% of the costs of previous repair methods.
