## METALCLAD CeramAlloy CP+AC Repairs Pitting and Corrosion on Hydroelectric Dam Tainter Gates

Client: U.S. Army Corps of Engineers (USACE)

Location: Dam and hydroelectric plant in the Eastern U.S.

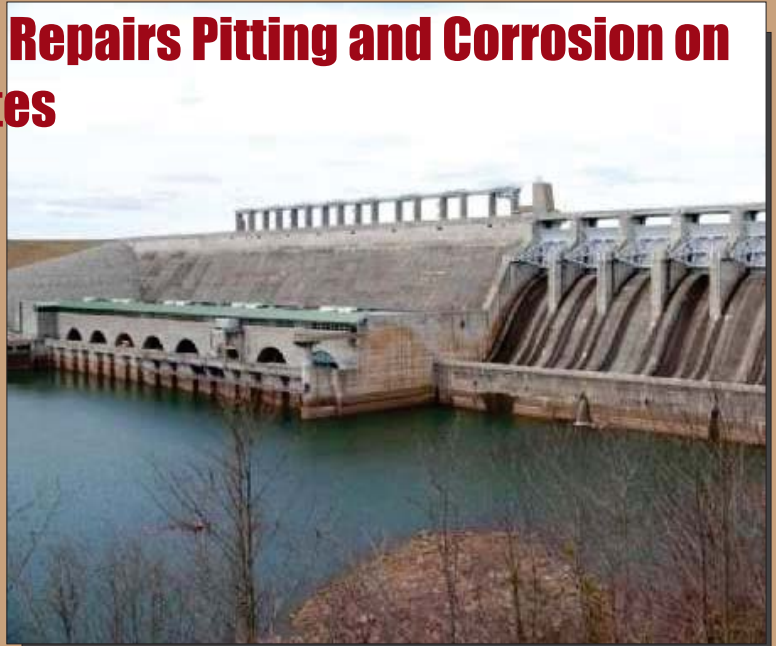
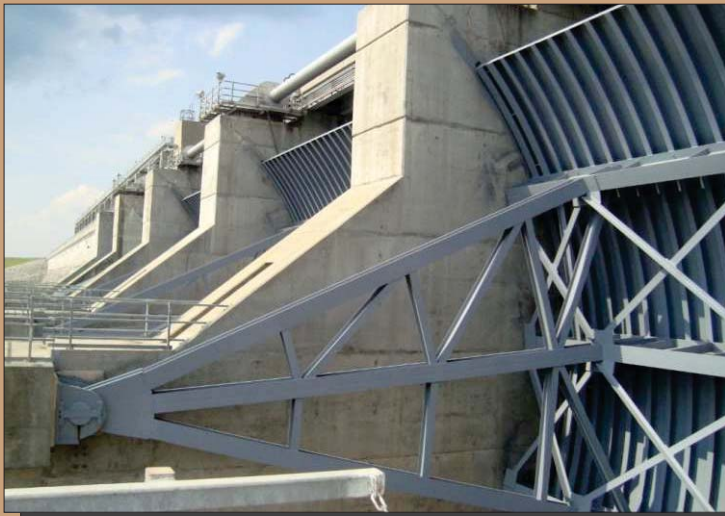
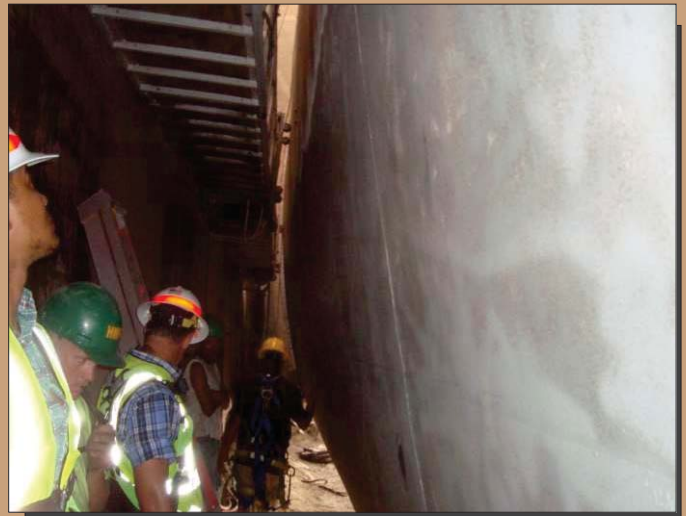
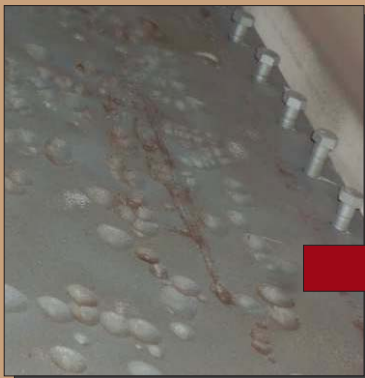
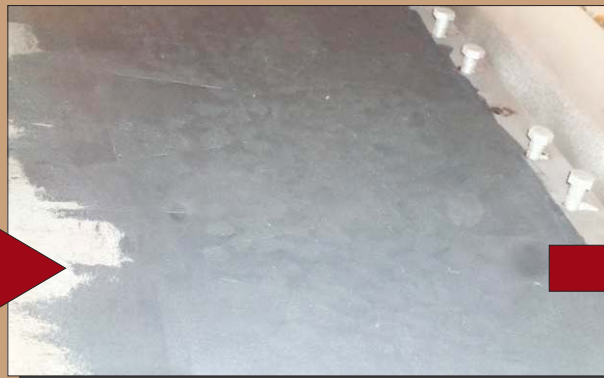
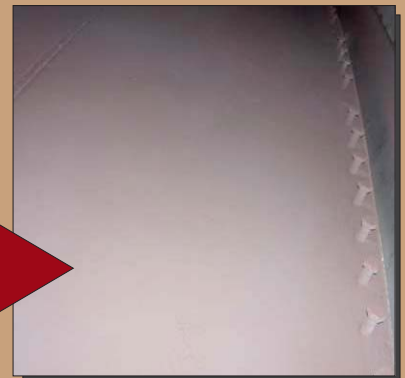
Problem: Severe corrosion and pitting on the dam's 10 Tainter gates.

Solution: After grit blasting, traditional repair methods consisted of 'puddle welding' the pitted areas. **CeramAlloy CP+AC** was used instead of welding to repair the corrosion damage. A standard multi-coat vinyl marine paint system was then applied to by the on-site contractor to comply with the USACE's specifications.
