## Waste Water Treatment Plant Salvages 'Unsalvageable' Pump Suction Housing with CeramAlloy

**Client:** Waste Water Treatment Facility

**Location:** Southwest Florida

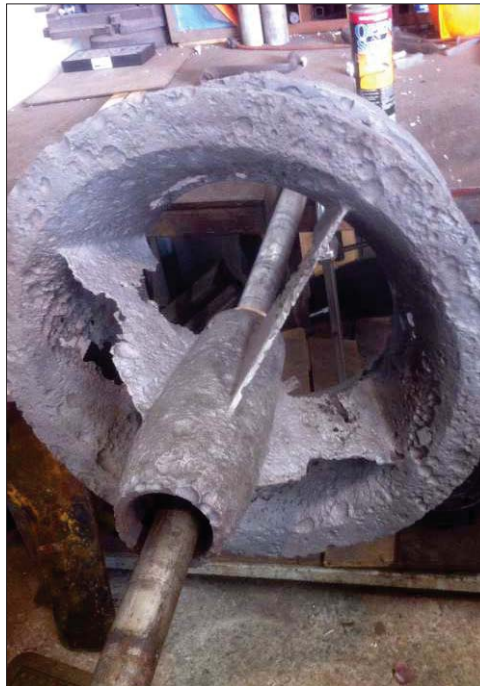
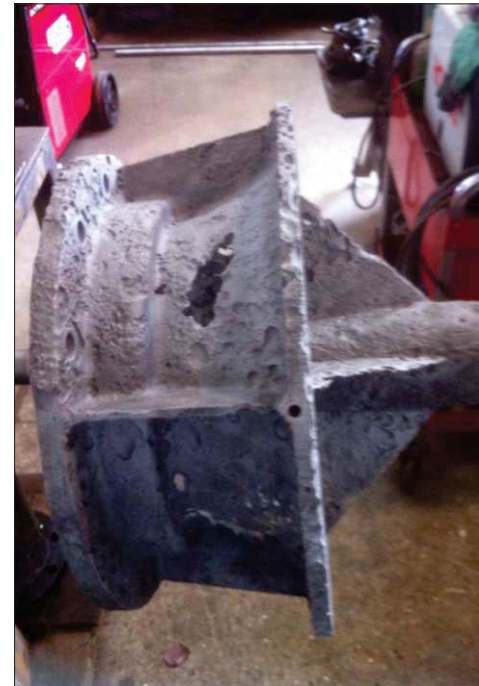
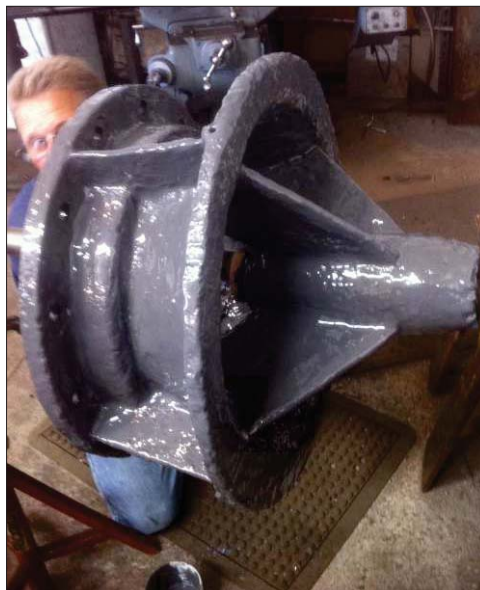
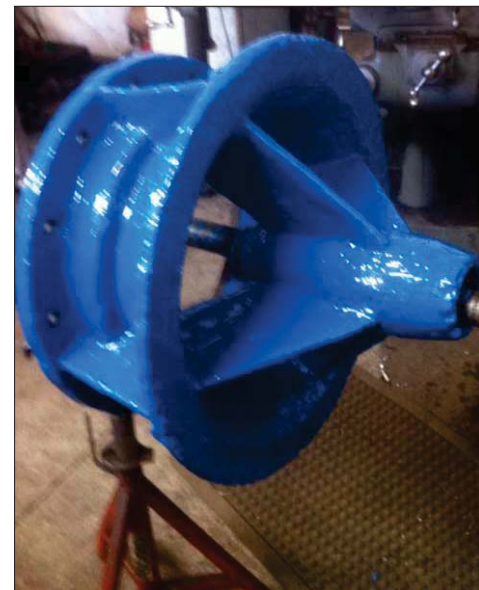
**Problem:** Severely eroded & corroded pump suction housing.

**Solution:** Grit blast – repair all eroded areas back to original shape and profile with CeramAlloy CP+AC. Reinforcement mesh was used to bridge holed or severely eroded areas. Two coats of CeramAlloy CL+AC were then applied to completely encapsulate the casing to protect it from future erosion and corrosion damage.

**Savings:** A new housing would have had to have been manufactured to spec at a cost of approximately \$10,000 with a 14 week lead time. Less than \$1,000 worth of CeramAlloy was used to repair this pump *and it took only one day!*
