Nuclear Power Station Saves Over \$20,000 Repairing Deteriorated Spool Piece with CeramAlloy

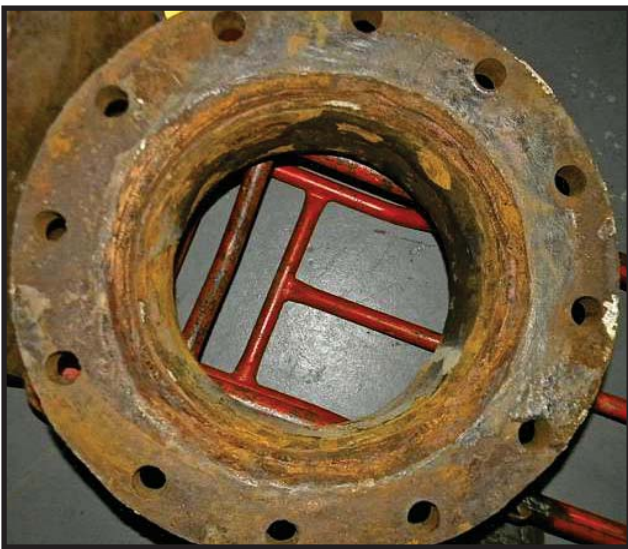
The component is a 14" diameter, cement lined, spool piece that is mounted between a large strainer and an isolation valve on the service water system at a nuclear power station. During a refueling outage, this spool piece was removed to allow for maintenance on an adjacent component. The deteriorated condition of the piece was unexpected. The cement lining was severely eroded as were the inside diameters of both the inlet and outlet flanges.

The onsite ENECON Northeast service team, was asked to accomplish abrasive blasting of the component so that plant engineers could make an assessment of the true condition. Once the spool piece was determined to be structurally sound, **METALCLAD CeramAlloy CP+** was used to rebuild the spool lining and damaged flanges and **METALCLAD CeramAlloy CL+** was used to totally encapsulate the surfaces exposed to the brackish river water.

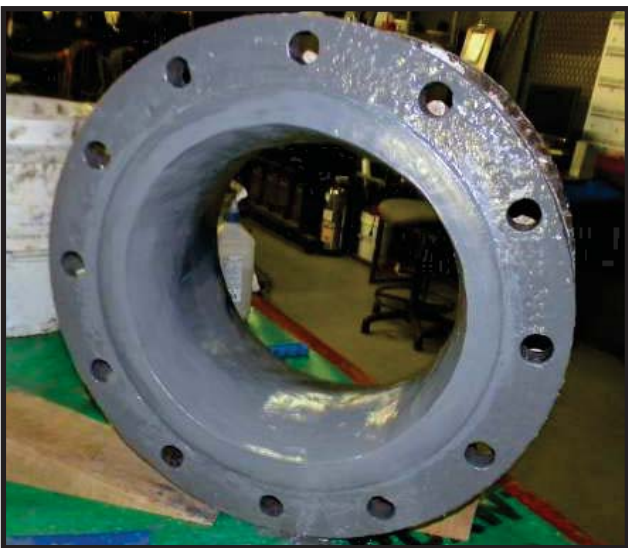
The spool piece was ready for re-installation just two days after removal at a fraction of the cost estimated for replacement - an excellent example of the practical benefit of "Repair don't Replace"!
